## **2023 LAKE WHITEFISH SPAWNING AND HABITAT INVESTIGATIONS IN THE VICINITY OF THE MATABITCHUAN GS, MATABITCHUAN RIVER**

Ontario Power Generation Inc.  
700 University Avenue  
Toronto, Ontario, M5G 1X6

July 2024

C. PORTT and ASSOCIATES  
56 Waterloo Avenue  
Guelph, Ontario, N1H 3H5  
[cportt@sentex.net](mailto:cportt@sentex.net)

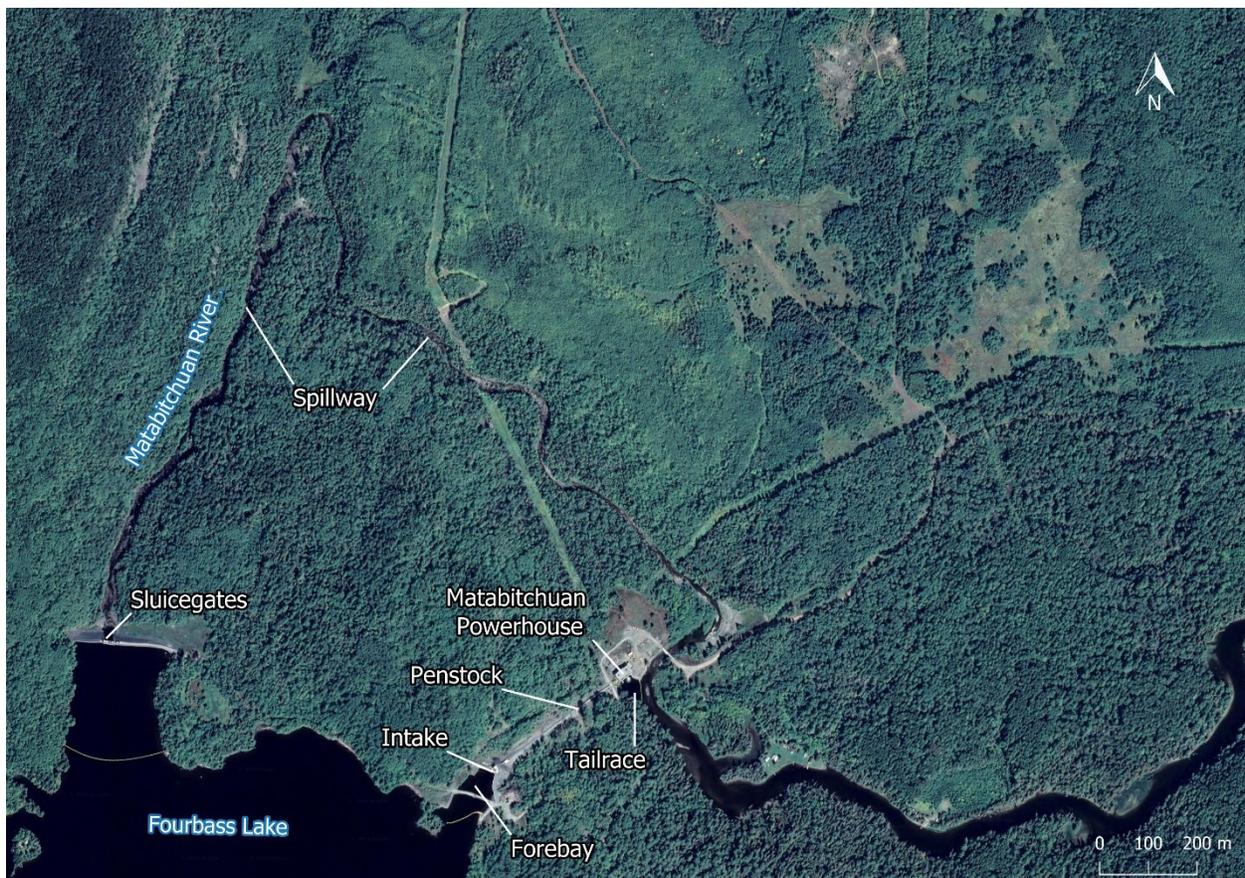
Figure 2-1. Matabitchuan River in the vicinity of the Matabitchuan GS.

Figure 2-1 identifies project infrastructure and illustrates the general waterbody and watercourse configuration in the vicinity of the GS. The Matabitchuan GS control dam (sluiceways) and intake structure are located on Fourbass Lake, approximately 800 m apart. The control dam and intake structure divert water to the powerhouse through penstocks, bypassing approximately 3 km of the Matabitchuan River that is now the spillway. Downstream from the GS the Matabitchuan River winds 3.6 km east to Lake Timiskaming (Figure 1-1; Figure 2-1). The low gradient of the river downstream of the GS means that the GS tailrace and the lower portion of the spill channel are readily accessible to Lake Whitefish from Lake Timiskaming.

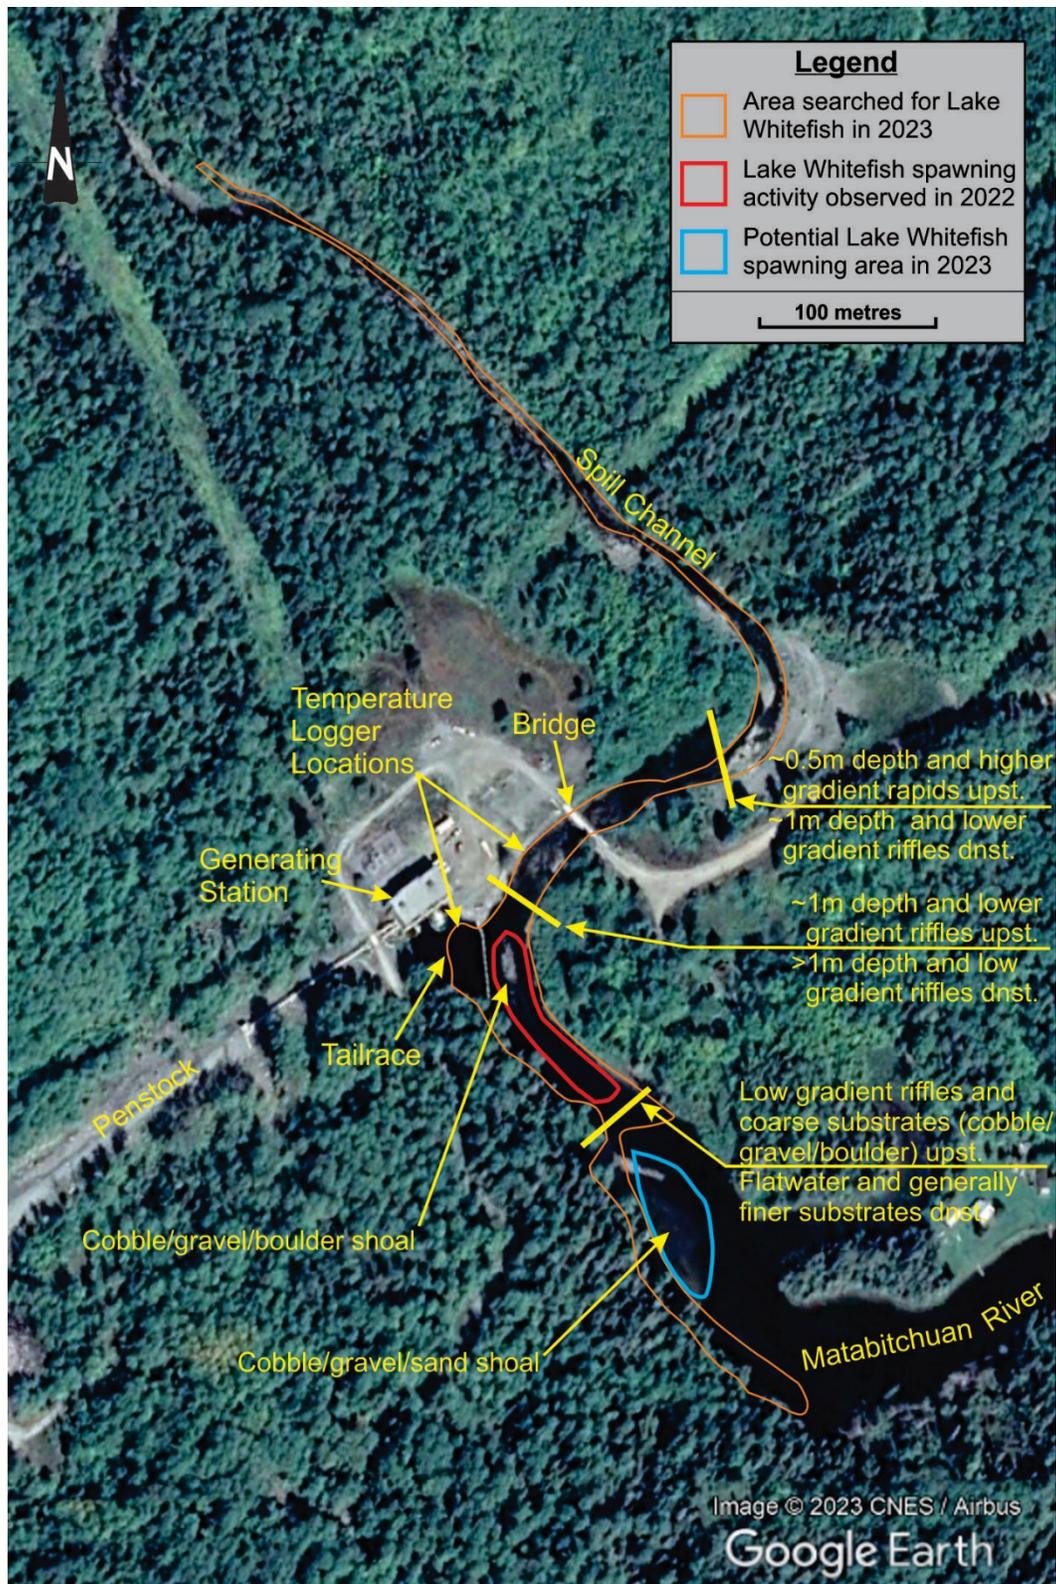
Figure 3-1. Area examined for Lake Whitefish on November 7 and 8, 2023, location of observed spawning activity in 2022, shoal considered to have high potential for spawning in 2023, locations of the temperature loggers, and general habitat characteristics.

The locations searched for spawning Lake Whitefish are shown in Figure 3-1. The areas investigated on November 7 included the tailrace and approximately 70 m along the northwest bank of the spill channel upstream of the tailrace; upstream and downstream from the road bridge; approximately 600 m along the southeast and east side of the spill channel upstream of the bridge, to investigate how far upstream Whitefish could possibly go; and, approximately 170 m along the southeast side of the spill channel downstream of the road bridge, which includes approximately 120 m of the river downstream of the tailrace. On November 8, approximately 286 m downstream of the tailrace on the west side of the river was added to investigate potential spawning areas farther downstream in response to the higher flow velocities in 2023 at locations where spawning activity had been observed in 2022, and the approximately 600 m along the southeast and east side of the spill channel upstream of the bridge was reduced to about 178 m because it was thought that, based on high water velocities, Whitefish could not spawn farther upstream. Otherwise, the areas investigated were the same both nights.

The area in which the spawning activity was observed in 2022 and the area where spawning activity is thought to have been occurring in 2023 (Figure 3-1) have the basic attributes of typical Lake Whitefish riverine spawning habitat, with sufficient depth for the rising of paired fish while emitting eggs and sperm, some gentle but complex currents and eddies, and coarse substrates. Flow through the GS was the same in 2022 and 2023 ( $10.3 m^3/s$ ). Flow through the spillway ranged from  $<1$  to  $3.4$  in 2022 and was approximately  $12 m^3/s$  in 2023. Consequently, in 2023 water velocities were higher (Figure 3-4) and may have been too high for Lake Whitefish to spawn in the location where spawning was observed in 2022.

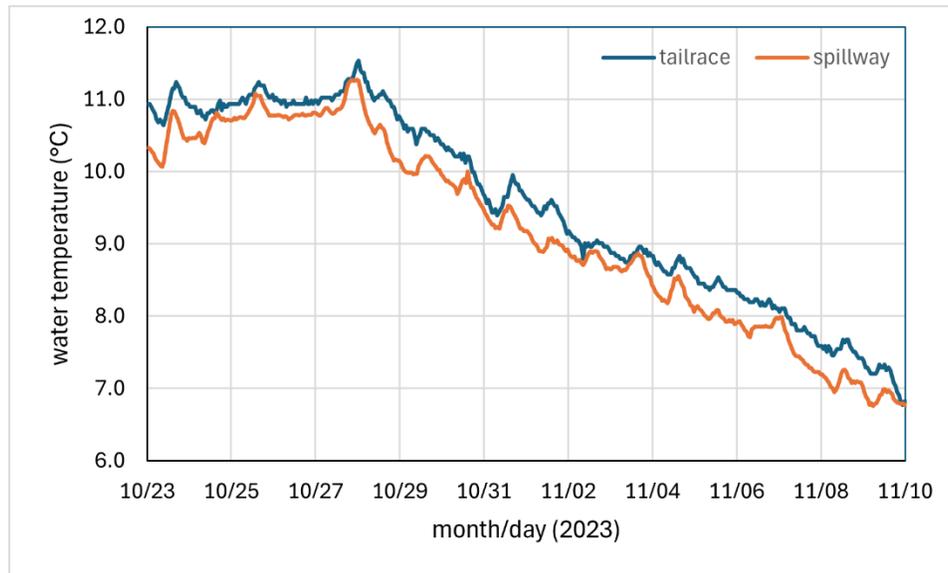
Figure 3-2. Water temperature in the Matabitchuan River, in the GS tailrace and at the bottom of the spillway, for the period October 23 – November 10, 2023.

The water temperature decreased steadily in the first week of November 2023, falling below 7.8°C for the first time in the spillway on November 6, and in the GS tailrace on November 7 (Figure 3-2). The rate of water temperature decline was similar for the spillway and the tailrace, but diurnal temperature fluctuations were greater in the spillway, consistent with the water's exposure to ambient air temperature in the 3 km long spillway, compared to water that passed through the GS. On the days of the spawning investigations (November 7 and 8) the logged water temperature in the spillway averaged 7.3°C and fluctuated between 6.8 and 8.0°C, while the logged tailrace water temperature averaged 7.7°C and fluctuated between 7.4 and 8.1°C. Water temperatures taken with the hand-held thermometer at the time of the evening observations, within the spill channel and downstream of the tailrace where the tailrace and spill channel flows begin to mix, ranged between 7.2 and 7.3°C, which is within the preferred spawning range for Lake Whitefish.

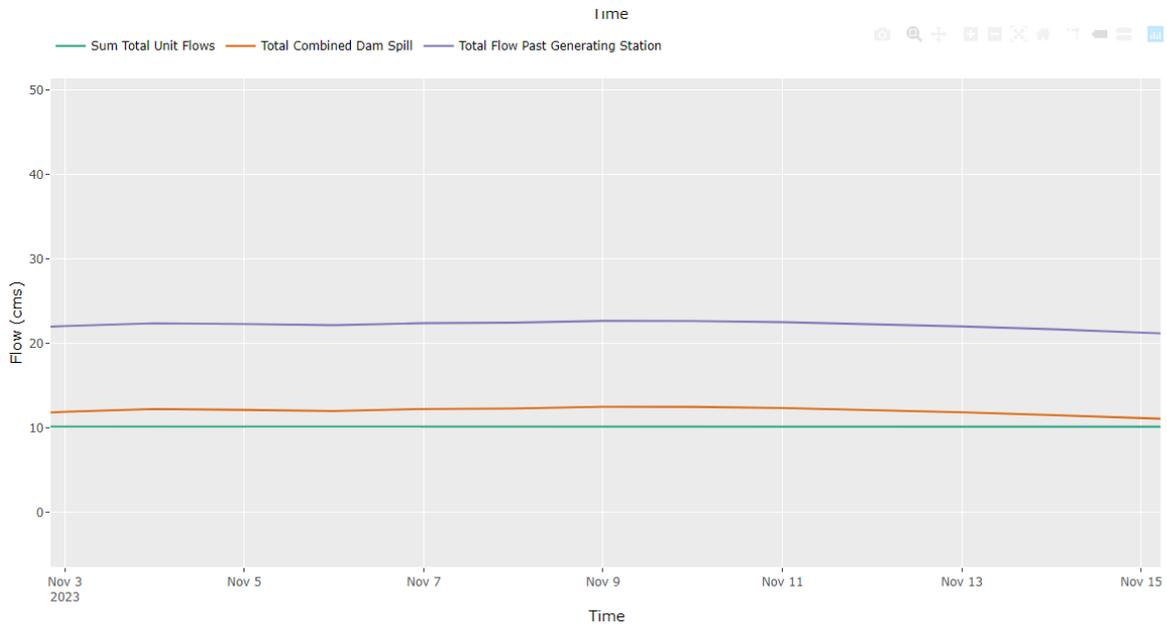
Figure 3-3. Discharge in  $m^3/s$  (cms) through the GS and tailrace (Sum Total Unit Flow), through the spillway (Total Combined Dam Spill), and the total river discharge (Total Flow Past the Generating Station) for the period November 3-15, 2023. Graph provided by OPG.

Discharges through the tailrace, the spill channel, and total discharge during the field investigations are presented in Figure 3-3. Total discharge was relatively constant at approximately 22 m<sup>3</sup>/s prior to and during the 2023 field investigations and almost equally divided between flow through the GS and through the spillway.

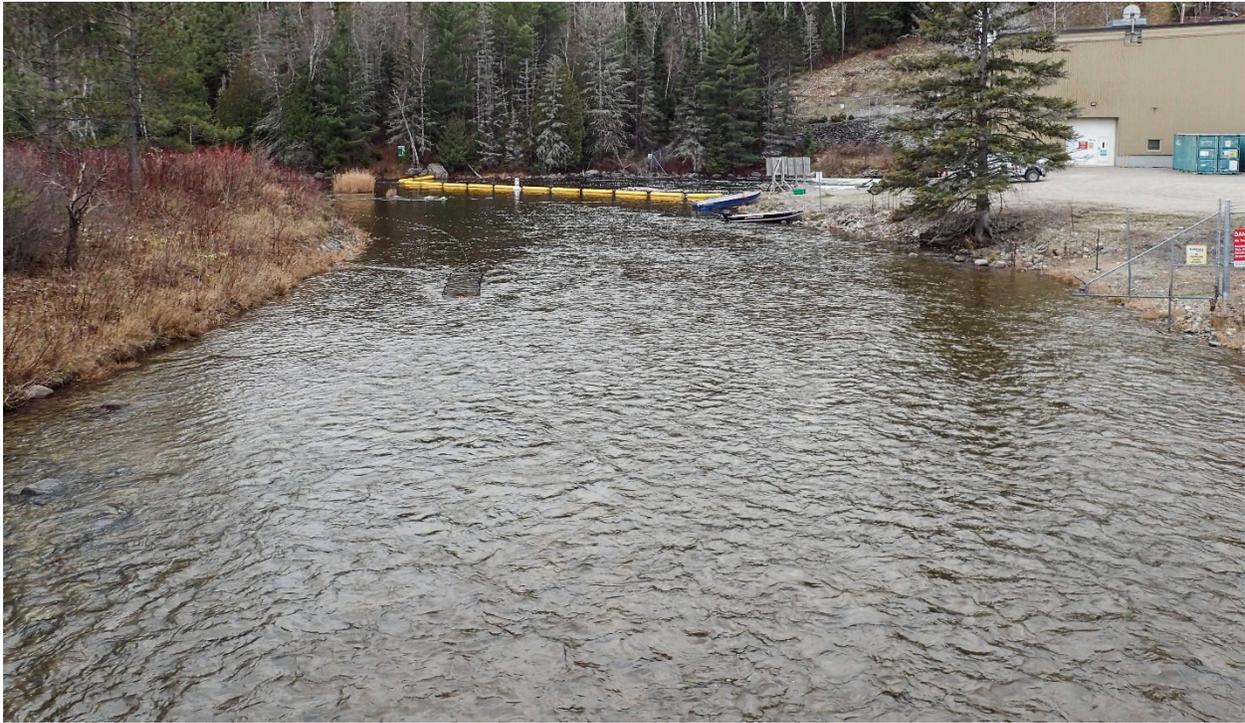
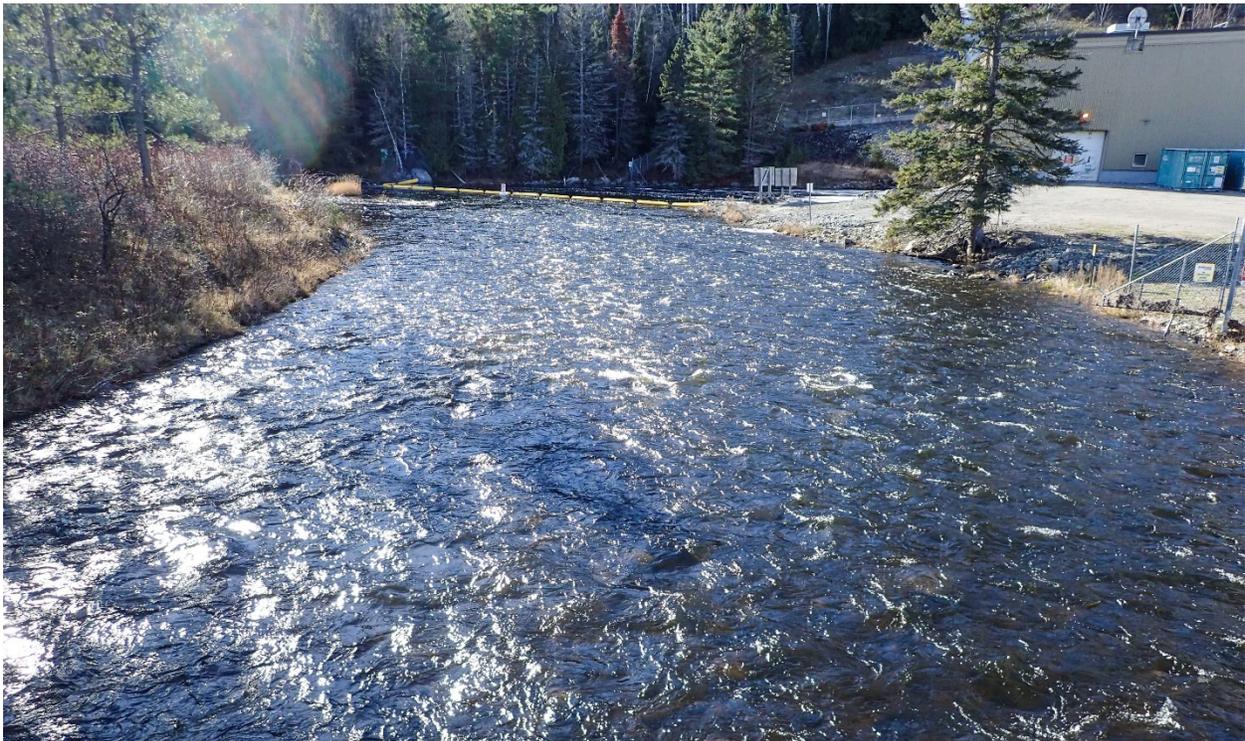
Figure 3-4. View downstream from the road bridge showing the difference in spill channel flow and velocity between 2022 (upper photo) when the spill channel discharge was  $3.4 \text{ m}^3/\text{s}$ , and 2023 (lower photo) when spill channel discharge was  $12.1 \text{ m}^3/\text{s}$ .

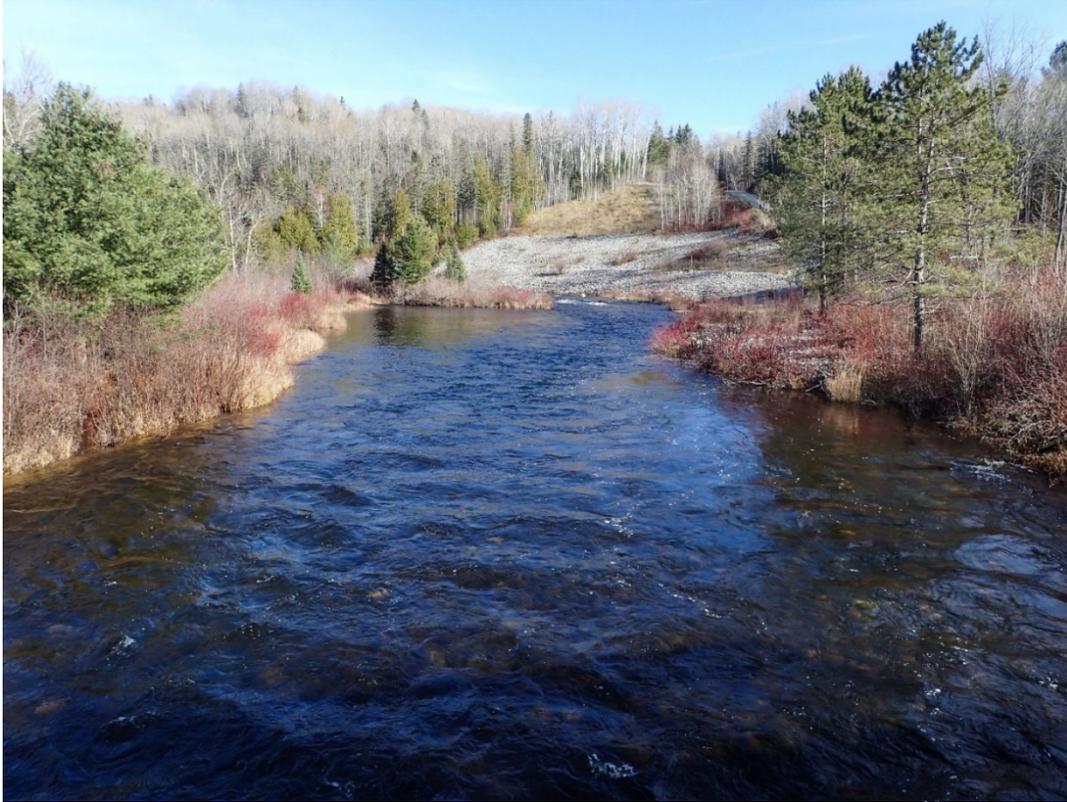
Figure 3-5. View upstream from the road bridge, showing the lower gradient portion of the spillway. November 8, 2023. The substrate is visible, illustrating the shallow nature of this area.

Downstream from the shoals described above the substrate is finer and the current velocities are lower and thought to be unsuitable for Lake Whitefish spawning. Upstream, the spillway is shallow (Figure 3-5) and soon becomes fast and turbulent (Figure 3-6). Based upon the examination of upstream spillway habitat characteristics conducted by C. Portt and Associates in 2020, there are no locations farther

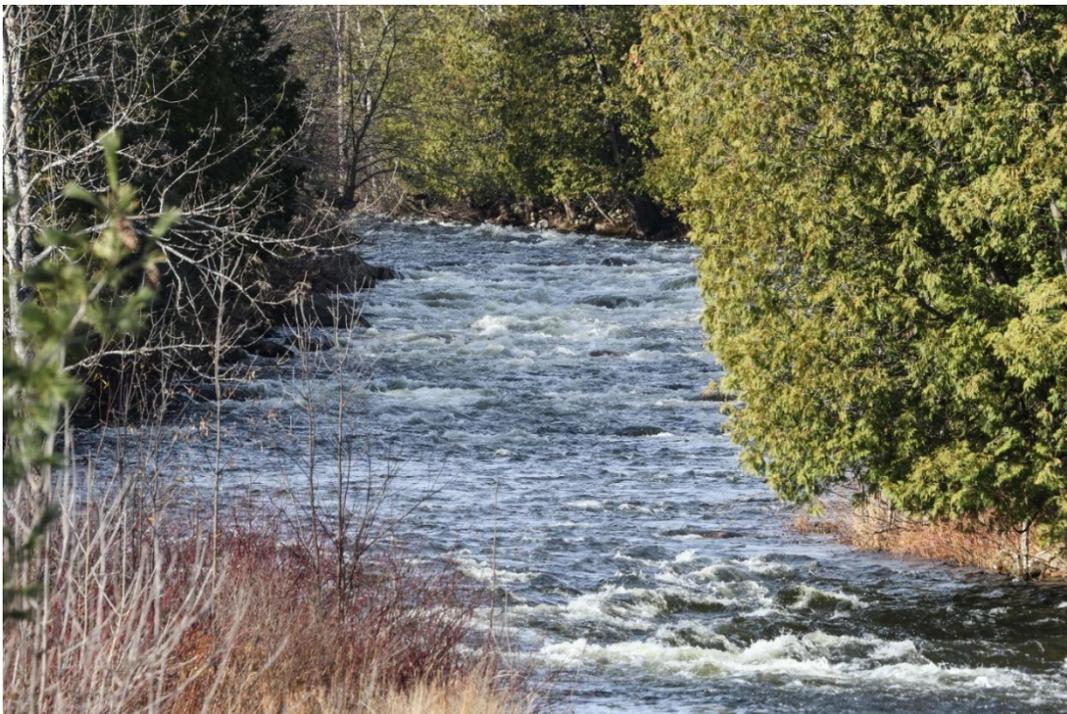
Figure 3-6. View of the spillway, looking upstream approximately 200 m upstream of the road bridge. November 8, 2023.
