Ontario Power Generation

# **Proposed Stinson Generating Station Life Extension Project (Final Draft)**

**Aquatic Environment  
Technical Support Document**

January 2025

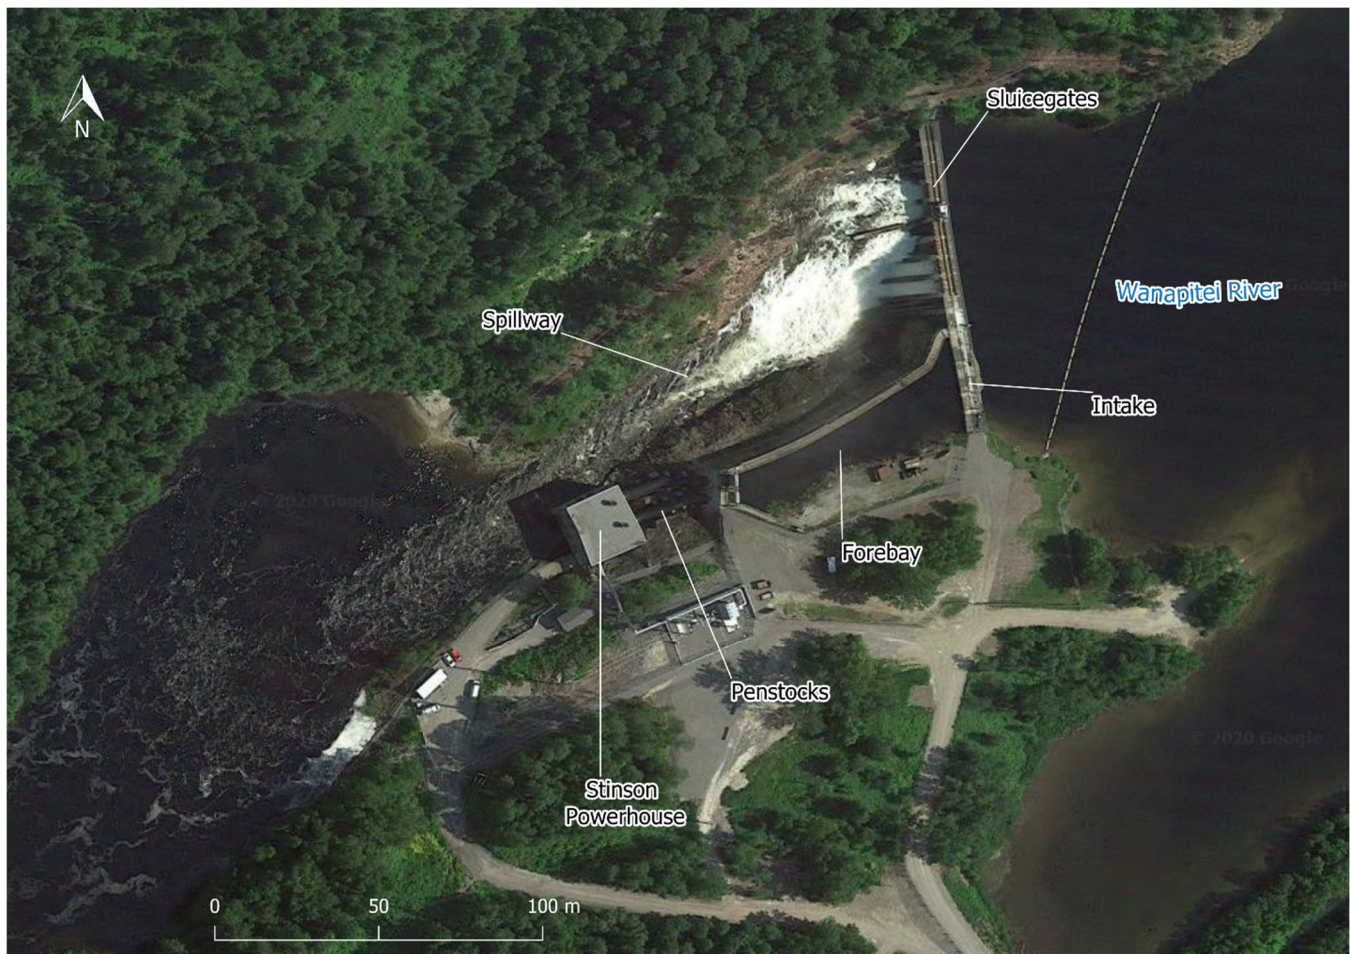
Figure 2-2 Site Overview

Figure 2-2 below is an aerial photograph of the site with key features labelled.

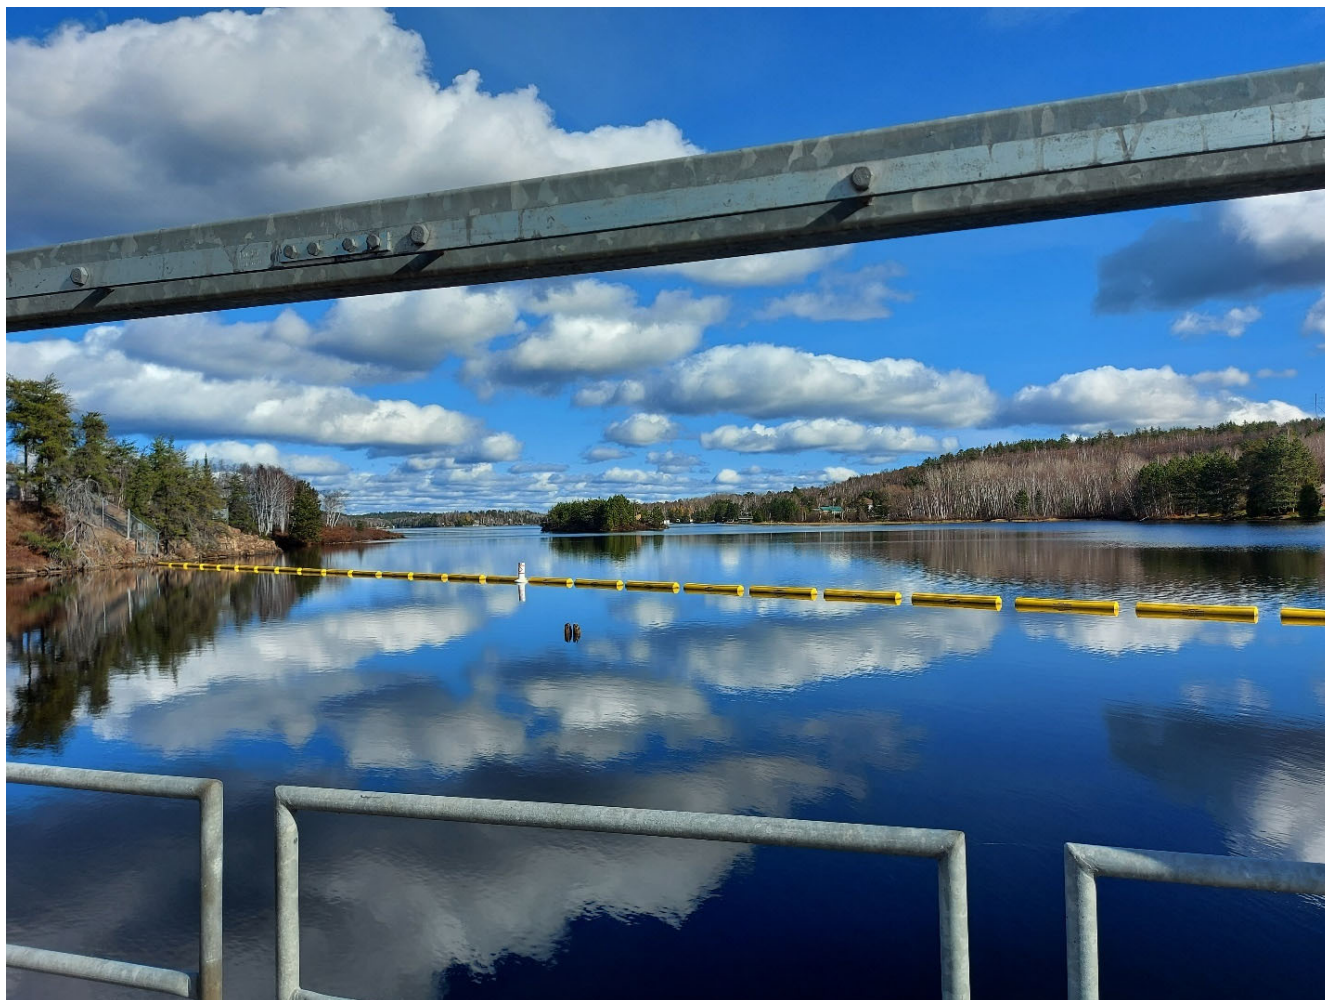
*Figure 2-3 Stinson Reservoir (looking upstream from the main dam)*

Figure 2-3 is a photograph looking upstream to the reservoir from the Stinson Dam.

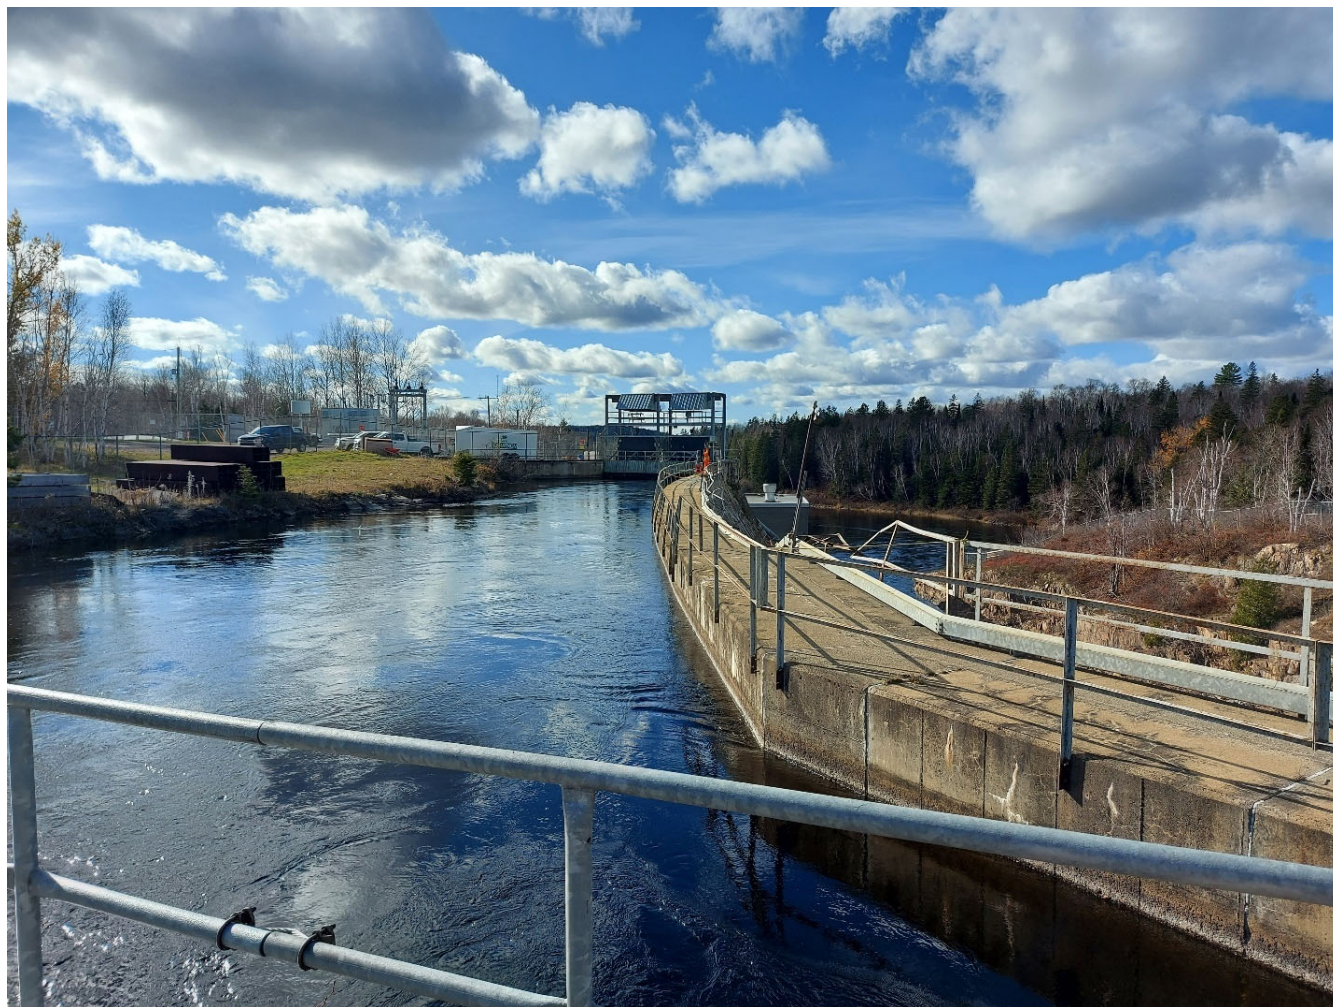
*Figure 2-4 Stinson Intake Canal*

Figure 2-4 shows the forebay to the Stinson powerhouse.

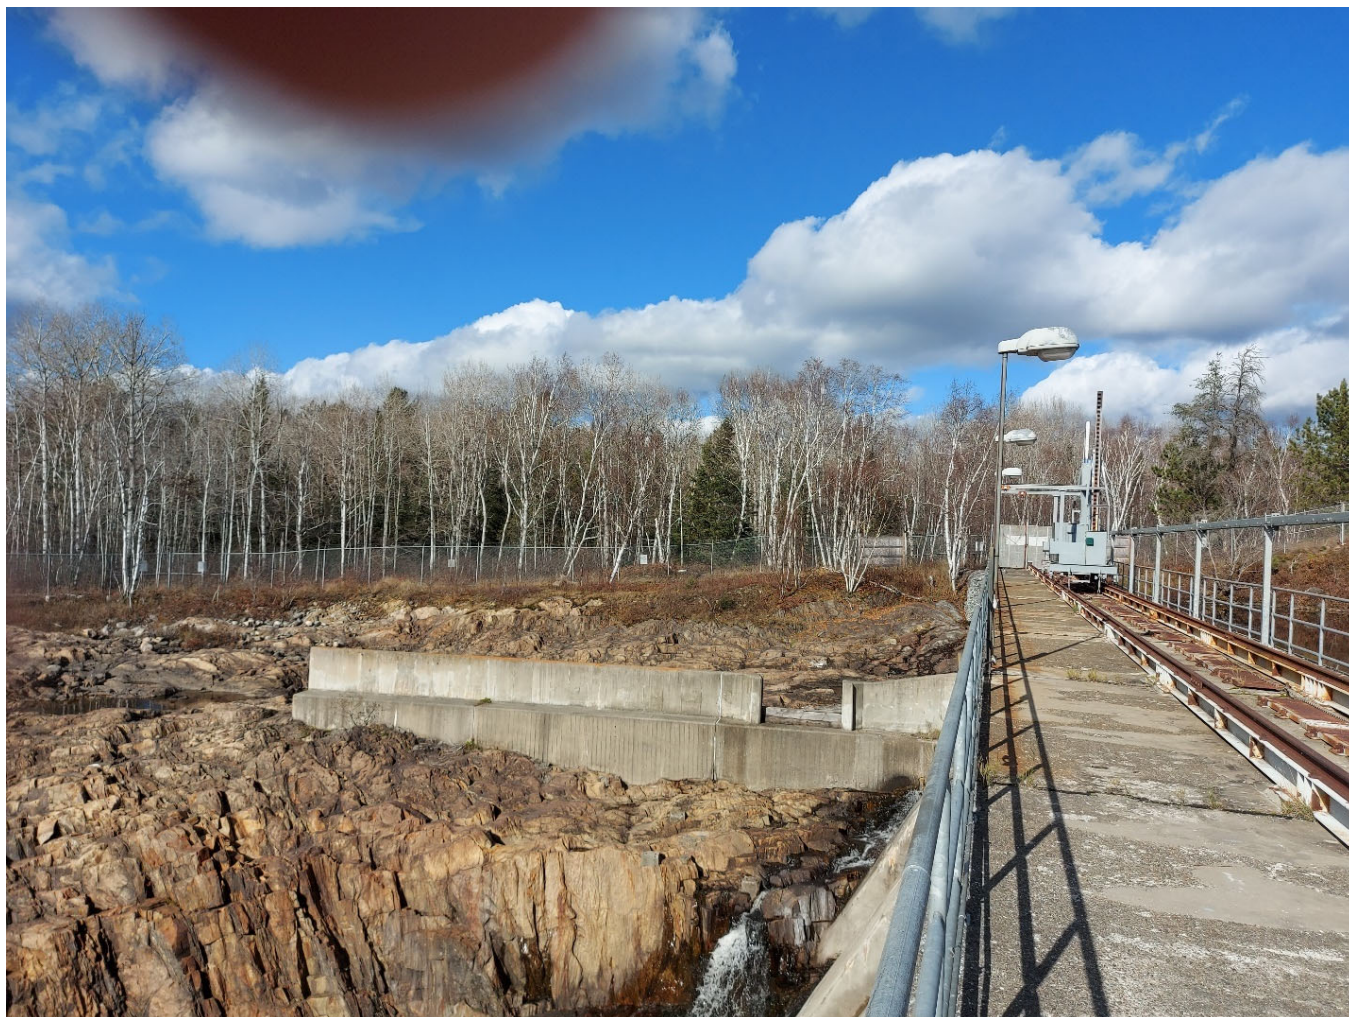
*Figure 2-5 Stinson Main Dam*

Figure 2-5 shows the Stinson Main Dam.

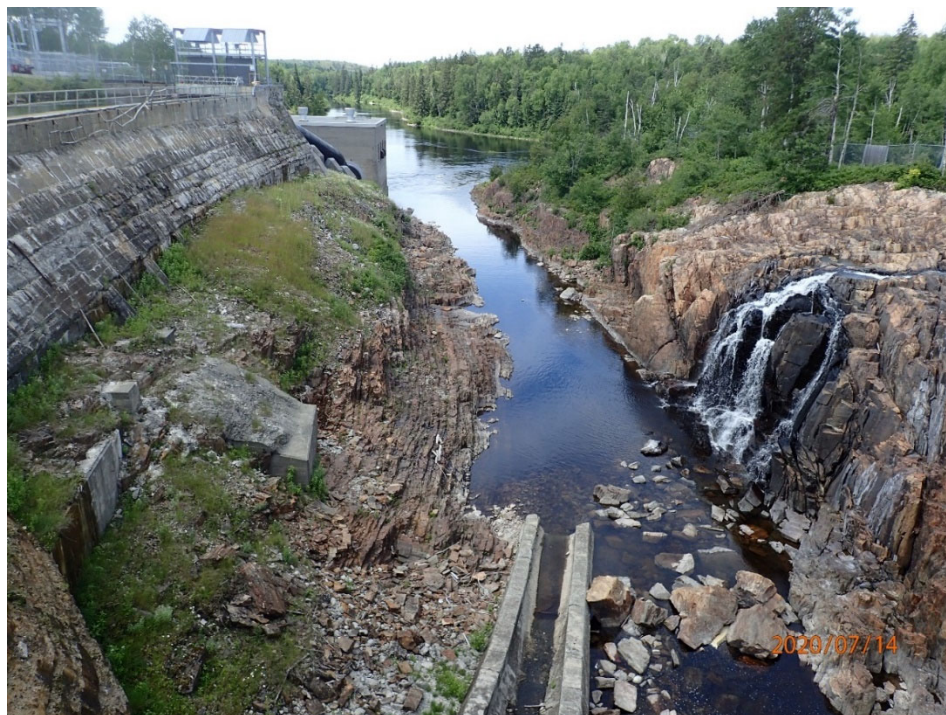
Figure 2-6 Stinson Spillway: Leakage Flow Only

Figure 2-6 and Figure 2-7 show the Spillway at no flow and partial flow.

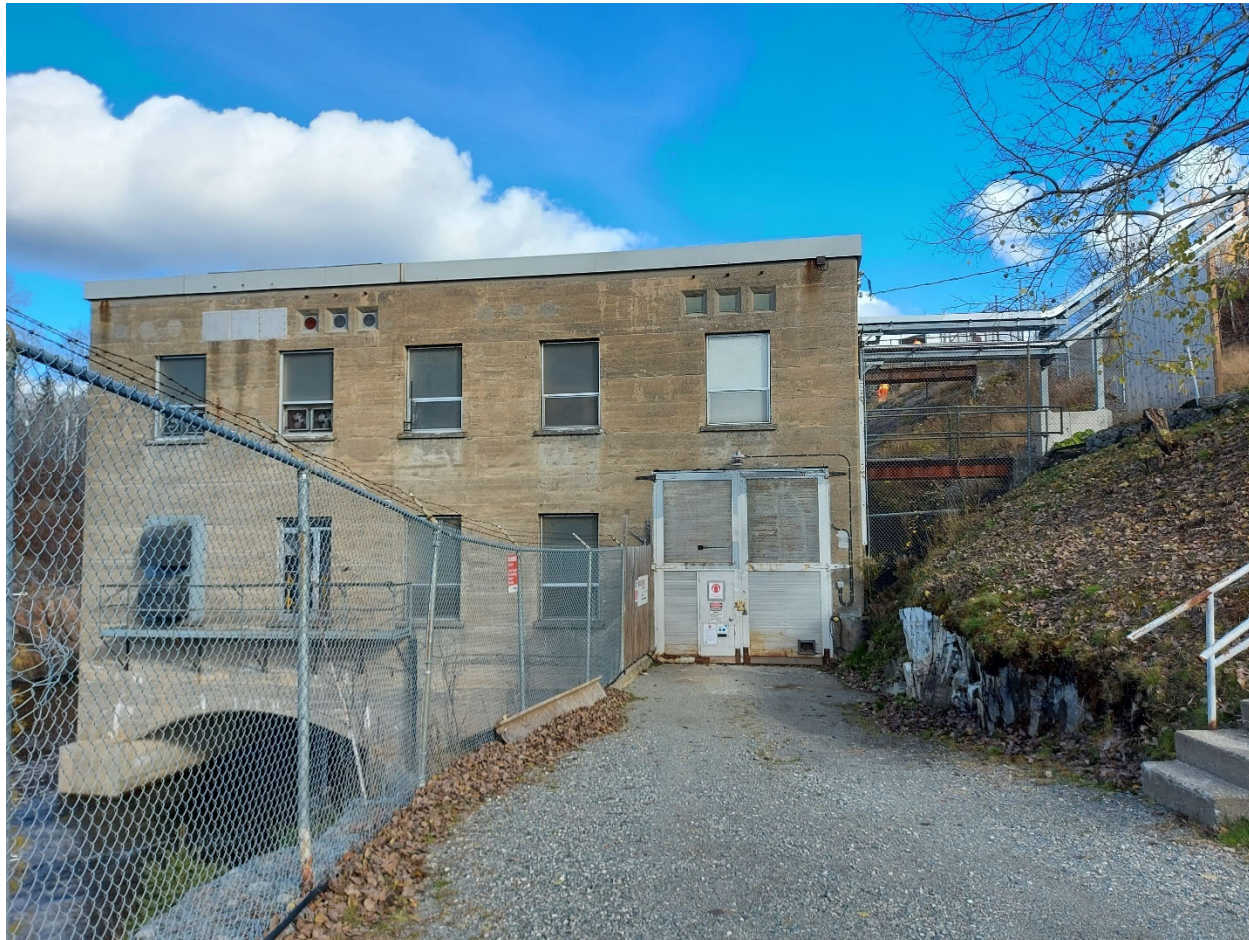
Figure 2-8 Stinson Powerhouse

Figure 2-8 shows the powerhouse and vehicular access.

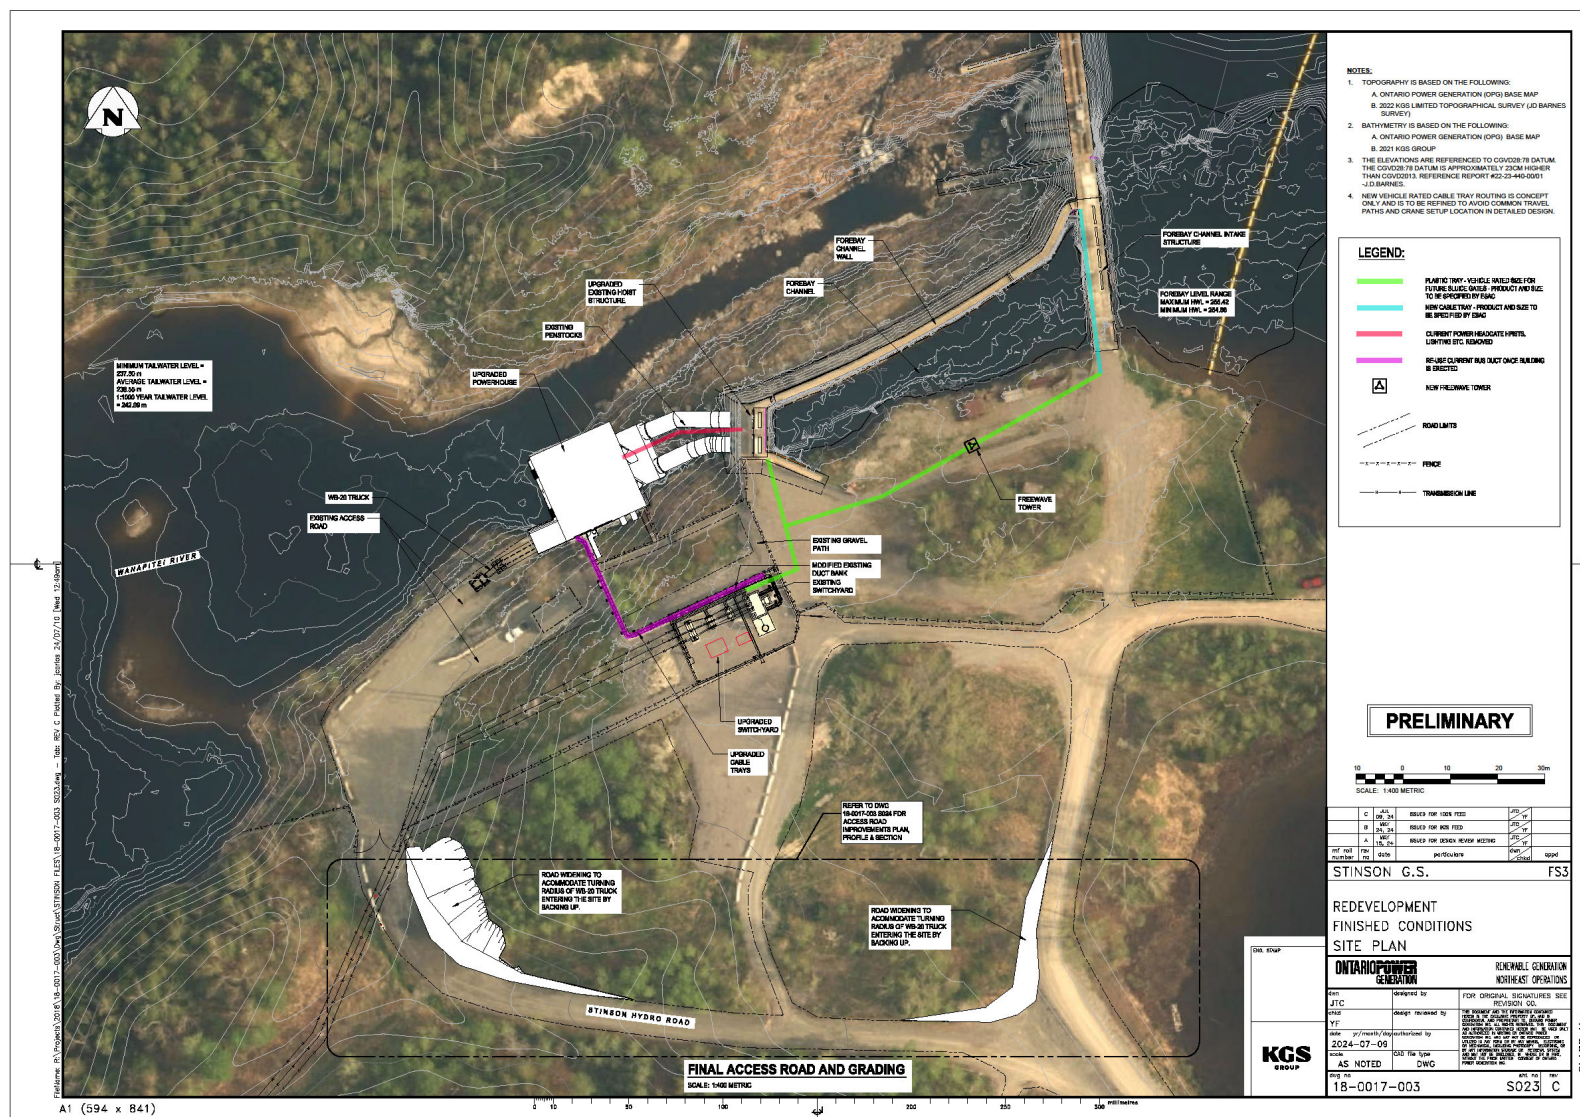
Figure 2-9 Proposed General Arrangement Site Plan for the Stinson GS

The proposed new site plan for the Stinson GS along with topographic and bathymetric elevations shown in Figure 2-9. The overall layout of the GS will remain largely unchanged from the existing situation. All of the major civil features of the GS will be retained in their current location including the dam, spillway, intake canal penstocks, powerhouse and tailrace. The powerhouse superstructure will be demolished and replaced. The powerhouse foundation will be re-used with some concrete repair work proposed. Two new turbine/generator units will be installed, and most of the powerhouse mechanical and electrical equipment replaced. With respect to the remaining civil works on site, the existing Main Dam and Sluiceway will be largely unaltered except for some minor work. The existing isolation gates will be refurbished (paint and new wheels), and a new hoist structure and motor will be installed. The existing Switchyard will have one new structure added to accommodate some update electrical equipment, but the overall size is not expected to change.

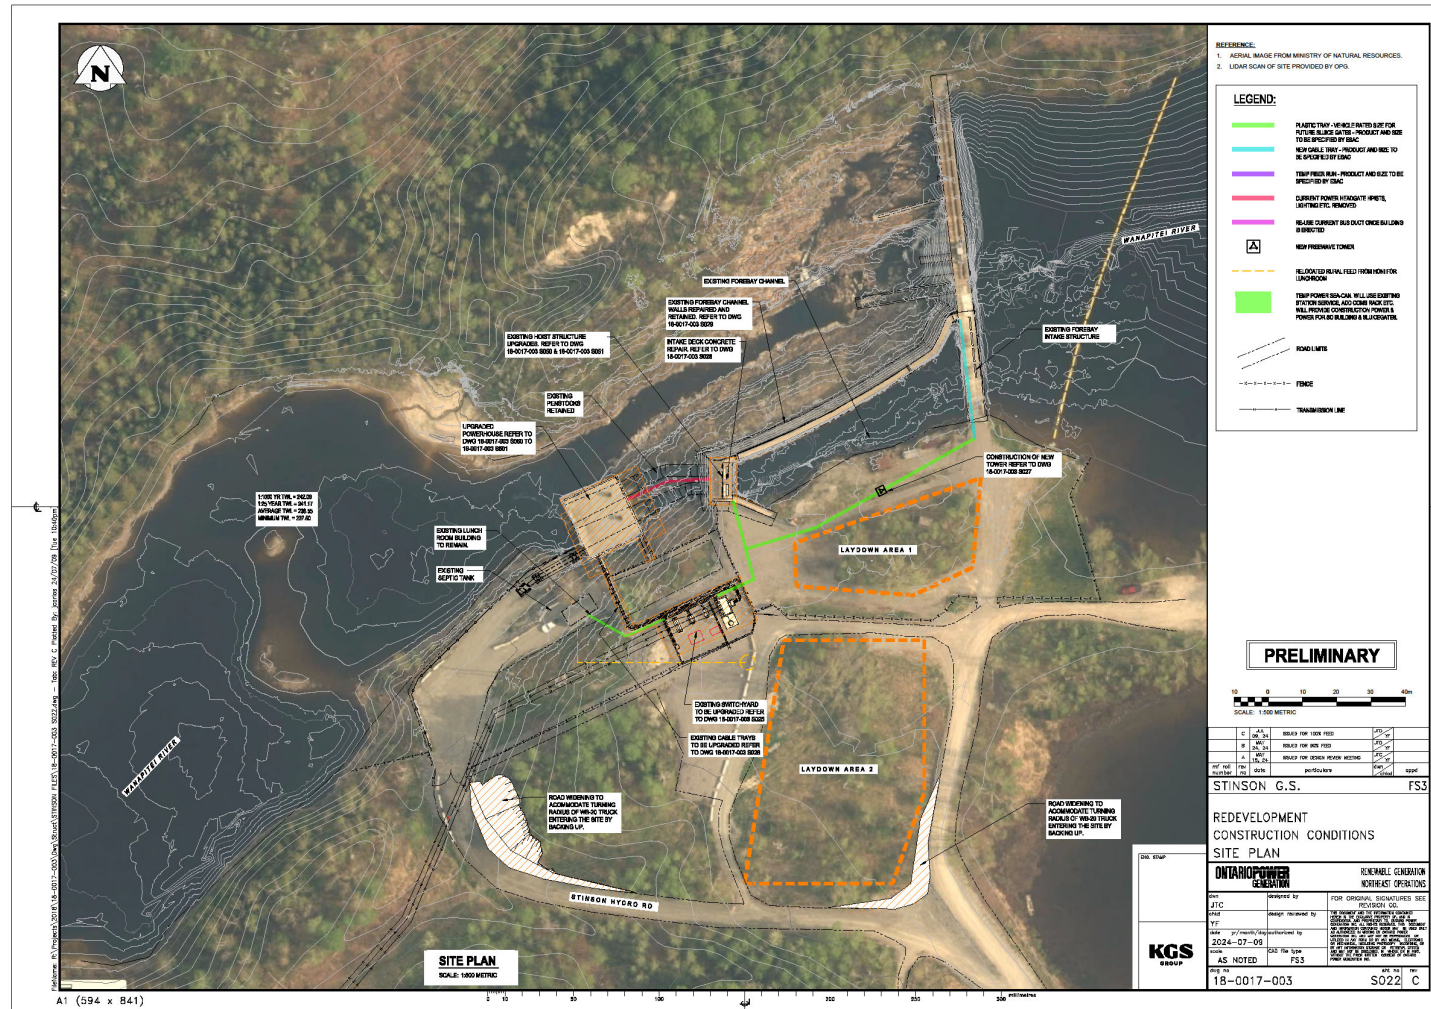
Figure 2-10 Proposed General Arrangement Site Plan for Construction for the Stinson GS

Figure 2-10 shows the site plan during the construction period. In order to provide working space for the construction, two laydown areas are proposed south of the intake canal and shown on the Figure. The repair work for man-made intake canal channel walls and intake deck are shown. Figure 2-10 and Figure 2-11 shows the proposed road modifications. These proposed road modifications will allow for improved accessibility for trucks. All the proposed road modifications occur on OPG property.

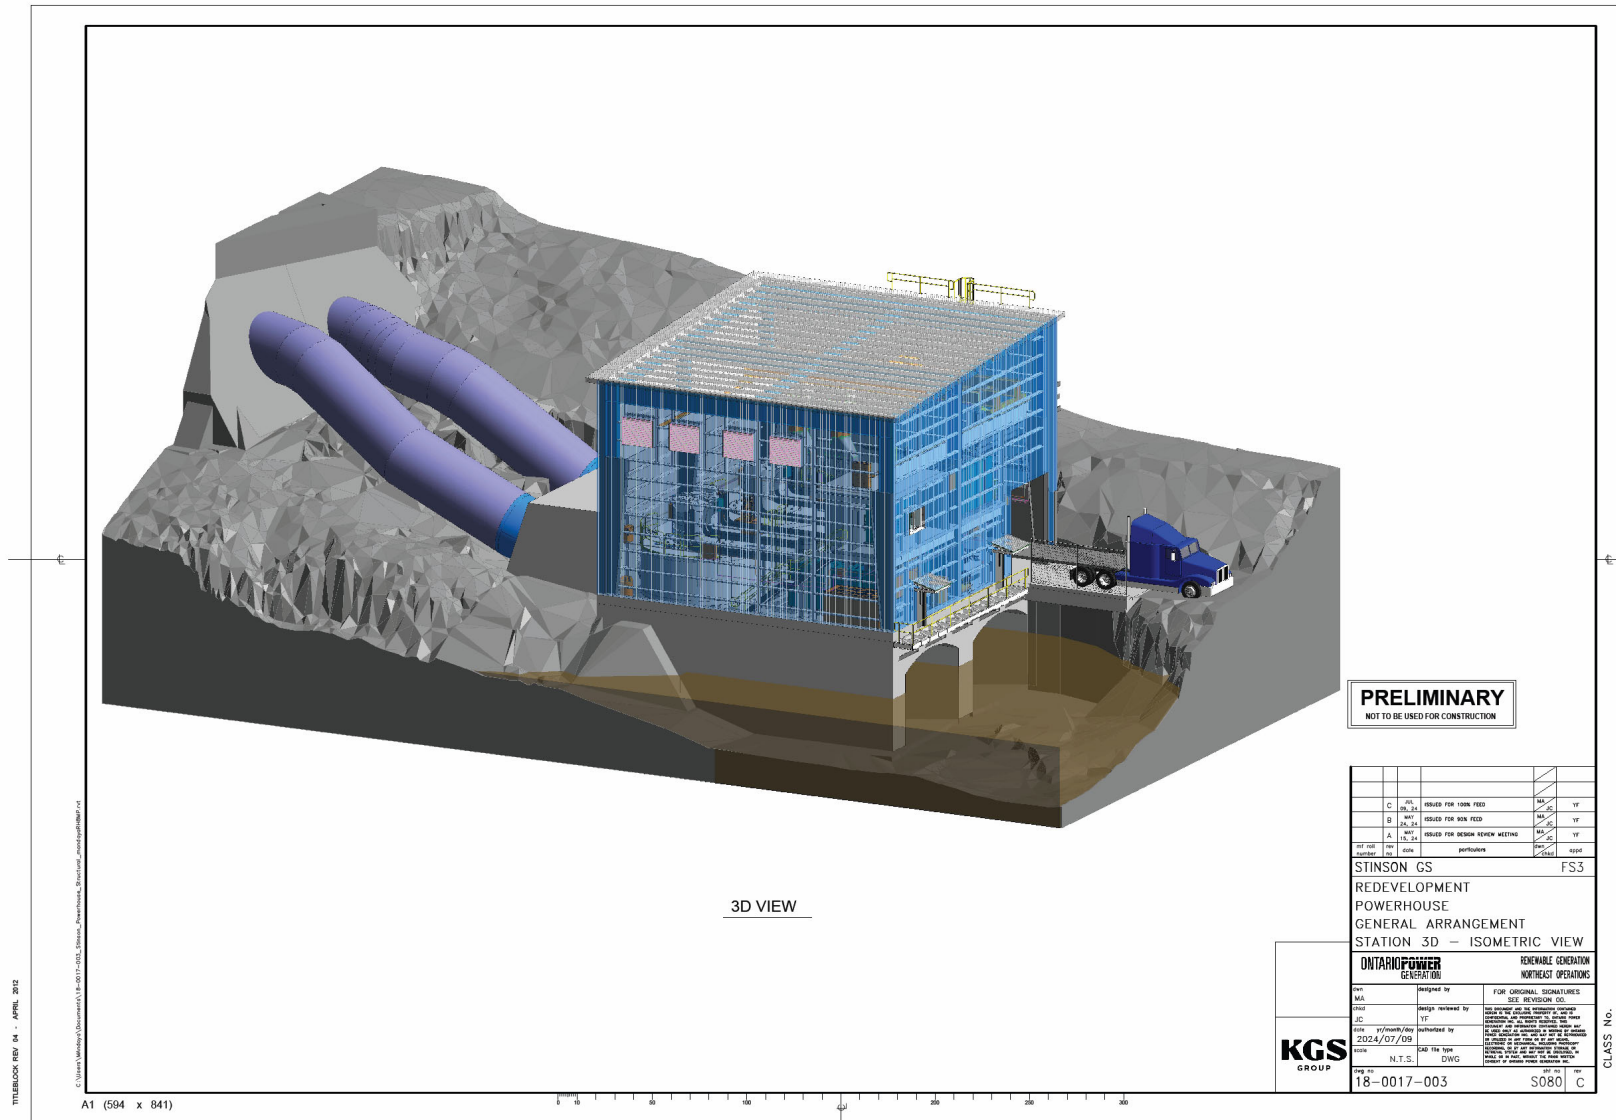
Figure 2-12 Powerhouse General Arrangement Exterior 3D View

Figure 2-12 and Figure 2-13 show the proposed re-built Powerhouse General Arrangement Exterior and Interior Conditions in a 3D View. Both Figures show the penstocks connecting to the north face of the powerhouse and water passages and vehicular access occurring to the south. They represent no changes from the existing conditions.

The total area of the powerhouse will remain the same, as a prefabricated steel building will be added directly on the existing foundation. The height of the new powerhouse will be 3.92 M taller to accommodate the new taller units and a powerhouse crane.

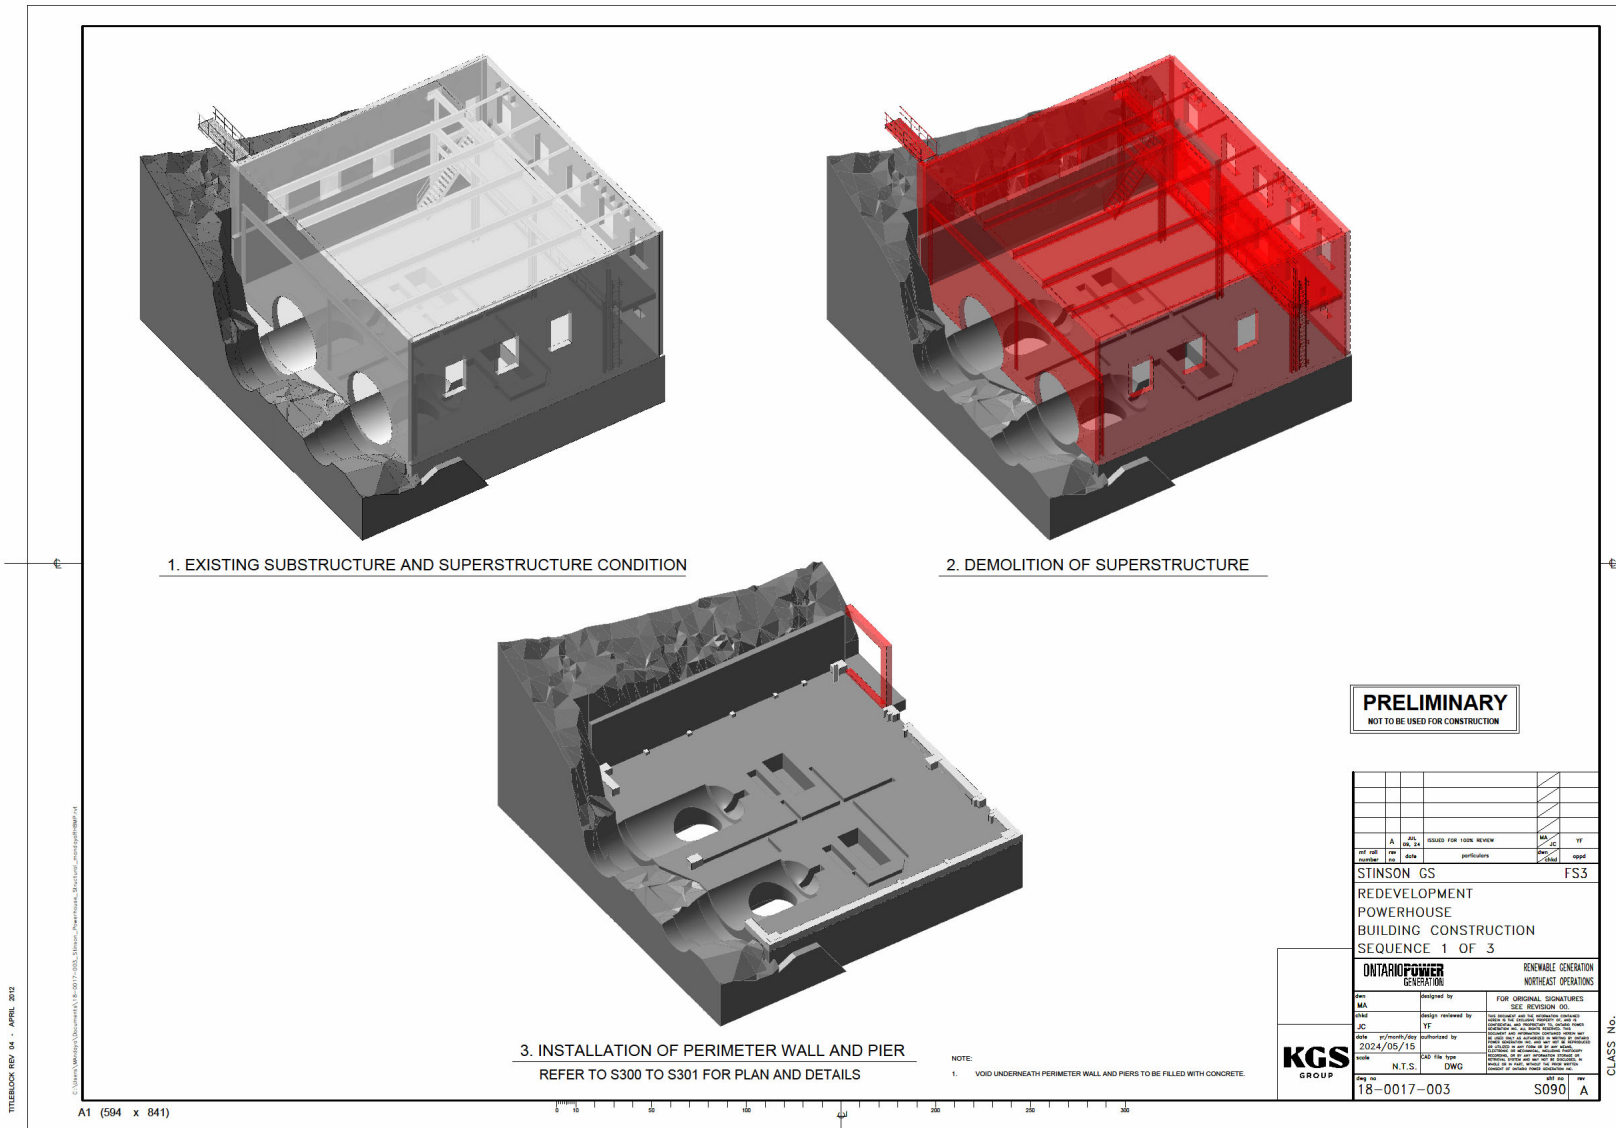
The existing powerhouse will be demolished but its foundation kept intact. Following that, the existing equipment will be removed.

Figure 2-18 Powerhouse Re-Development Sequence 1 – Demolition

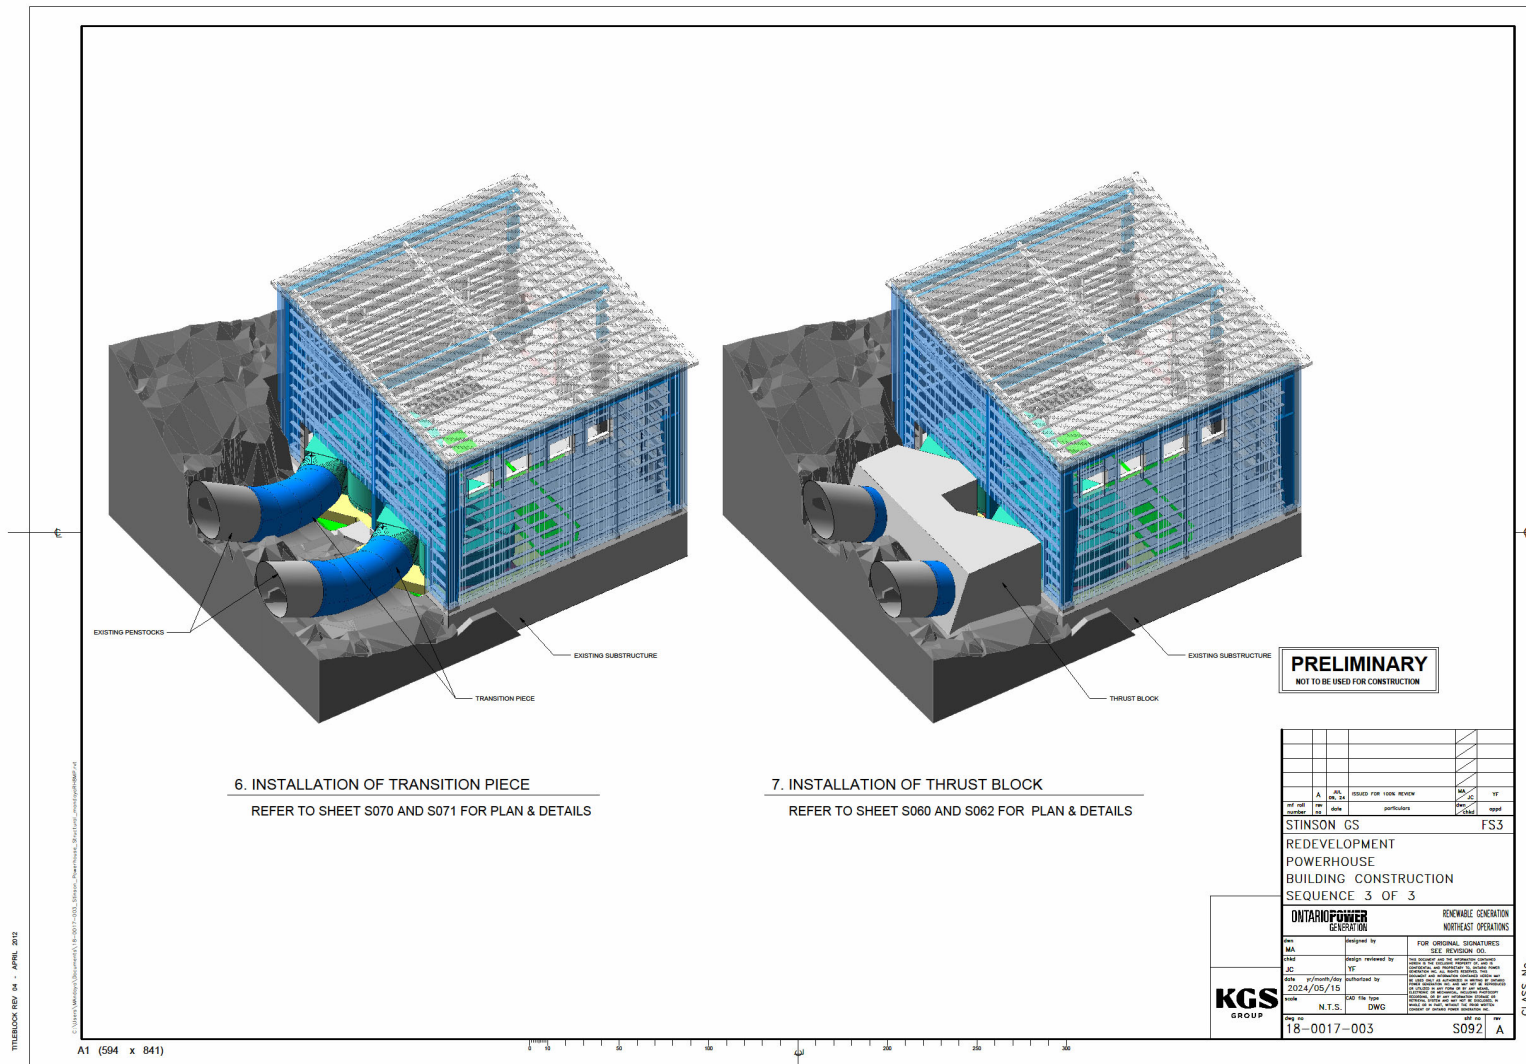
*Figure 2-21 Powerhouse Construction – Installation of Transition Piece and Thrust Block*

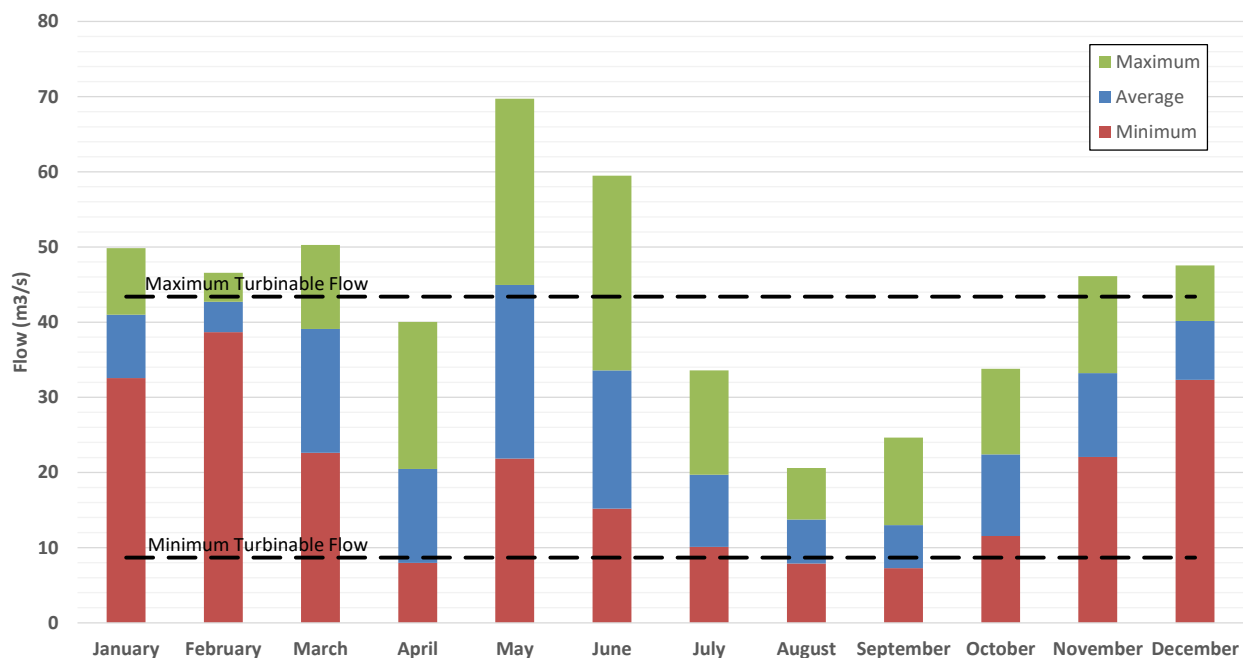
Figure 3-2 Average, Maximum, and Minimum Monthly Flows at Stinson GS

Total daily flow records for the Wanapitei River at Stinson GS were provided by OPG for the period 1999-2019. OPG also provided the spill flow and turbine flow records for the generating station for use in this study. Flows on the Wanapitei River are generally controlled by the operation of the Wanapitei Lake Dam, which regulates water levels on Wanapitei Lake. The operation goal for the dam is to maintain proper balance between power production and impacts of flooding downstream and the effects of upstream high-water levels on lake residents. In general, the dam is opened gradually over the winter to lower the lake level in anticipation of the spring thaw. At the onset of the freshet, flow through the dam is reduced to let the local freshet pass through the river system and allow the Lake to start filling. Monthly average and maximum flows are shown on Figure 3-2 and are reflective of the Wanapitei Dam operating strategy described above. During the winter months, flows are fairly steady as the dam is opened to draw the lake level down. The average flow for April drops notably compared to winter flows, as the dam is closed to prepare for the freshet. Largest flows occur in May and June as freshet flows pass through the system. The lowest flows occur in the late summer and early fall as water is held in Lake Wanapitei for recreational purposes (KGS, 2021).

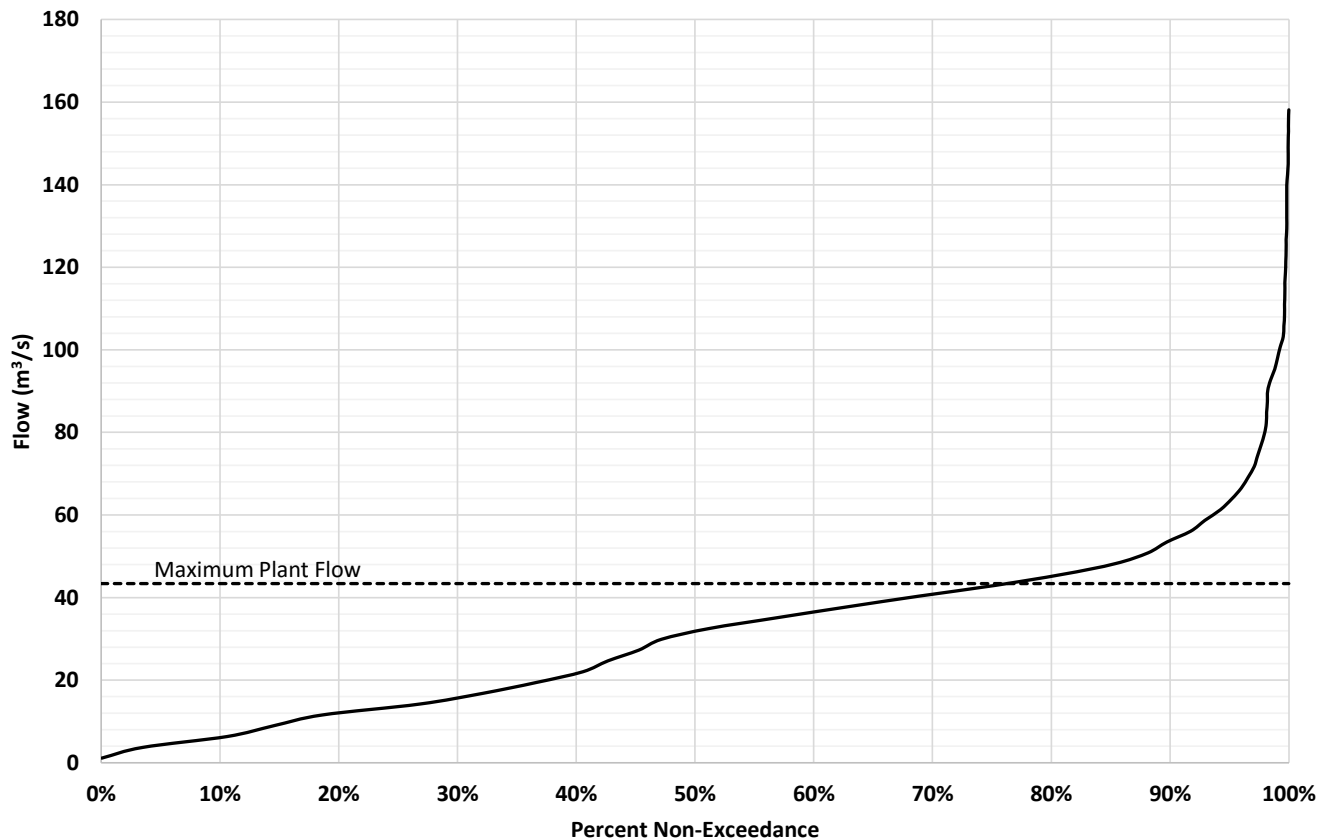
Figure 3-3 Wanapitei River Flow Duration Curve

A flow duration curve for Wanapitei River flows between 1999 and 2019 is shown on Figure 3-3. Approximately 75% of the recorded flows are below the current maximum plant capacity of approximately 43.4 m<sup>3</sup>/s.

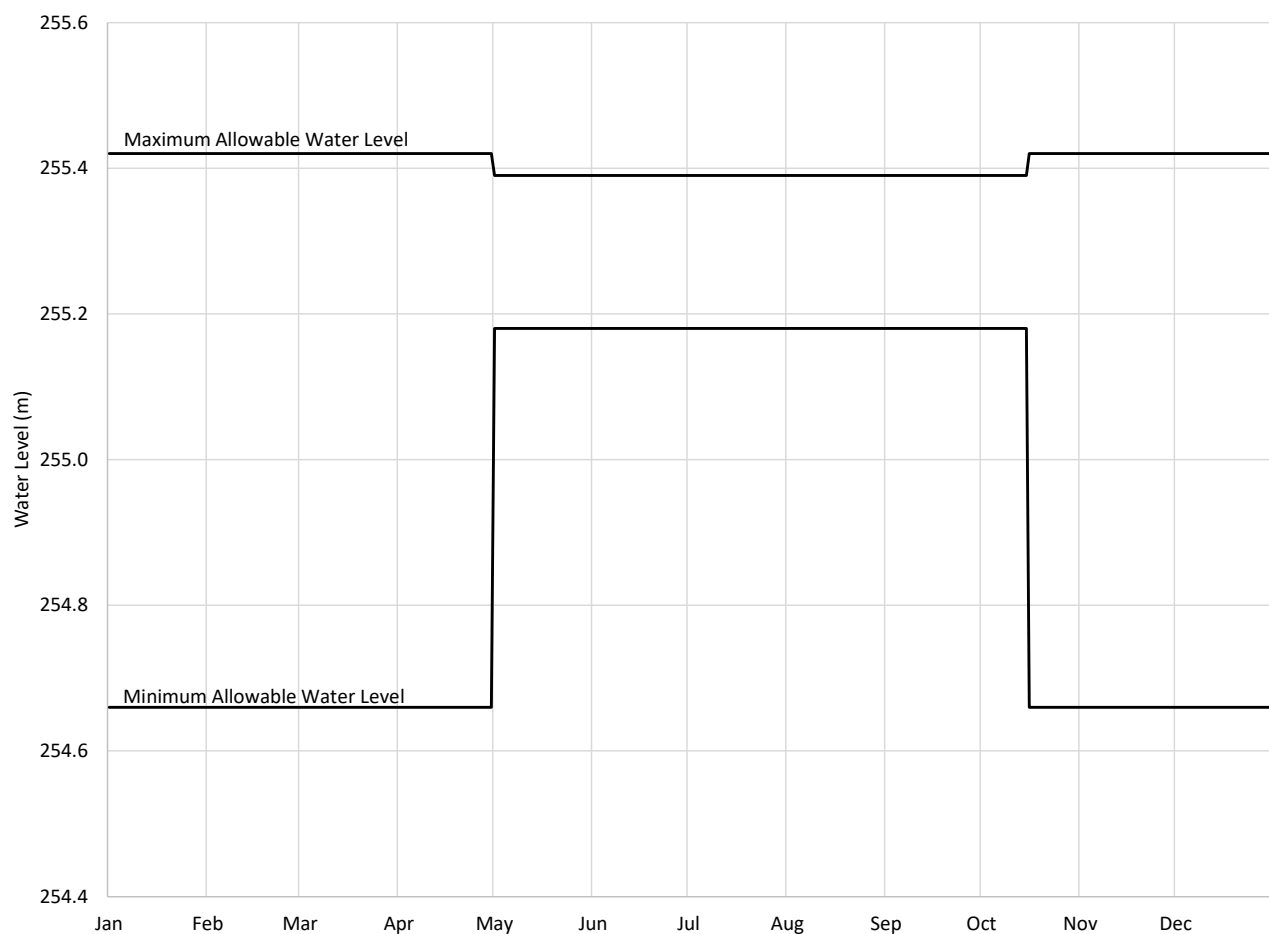
Figure 3-4 Stinson GS Headwater Level Operating Range

Headwater levels on the Wanapitei River above Stinson GS are measured and recorded by OPG on a daily basis using a pressure transducer gauge (ID# 02DB053).

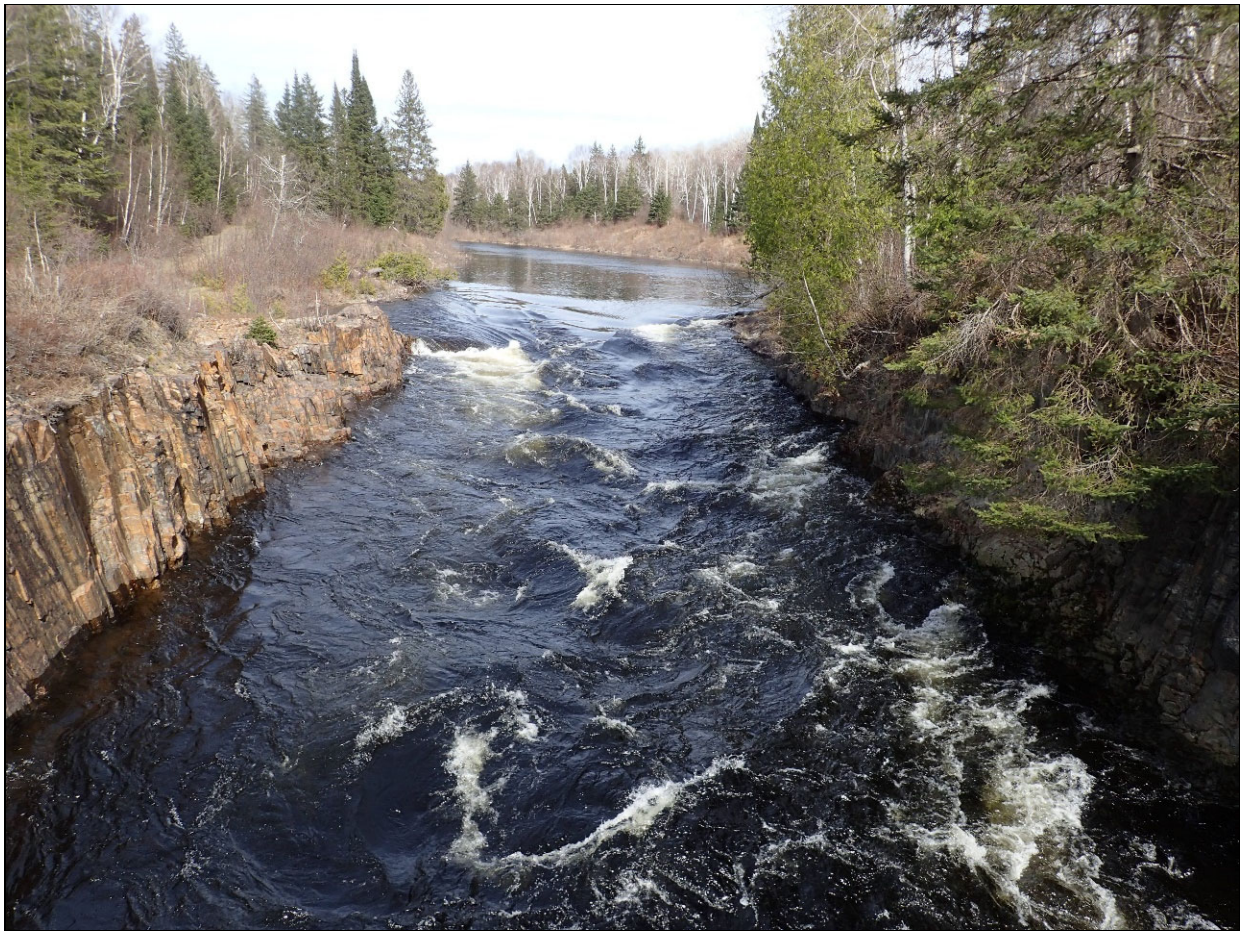
There is a bedrock chute (Timmins Chute) (Figure 4-5) approximately 0.8 km downstream from the Stinson GS which is likely a barrier to upstream fish passage under high flows and may be a significant impediment under other flows.

*Figure 3-5 Upstream Portion of Timmins Chute, Viewed from the Snowmobile/Pedestrian Bridge. May 9, 2022.*

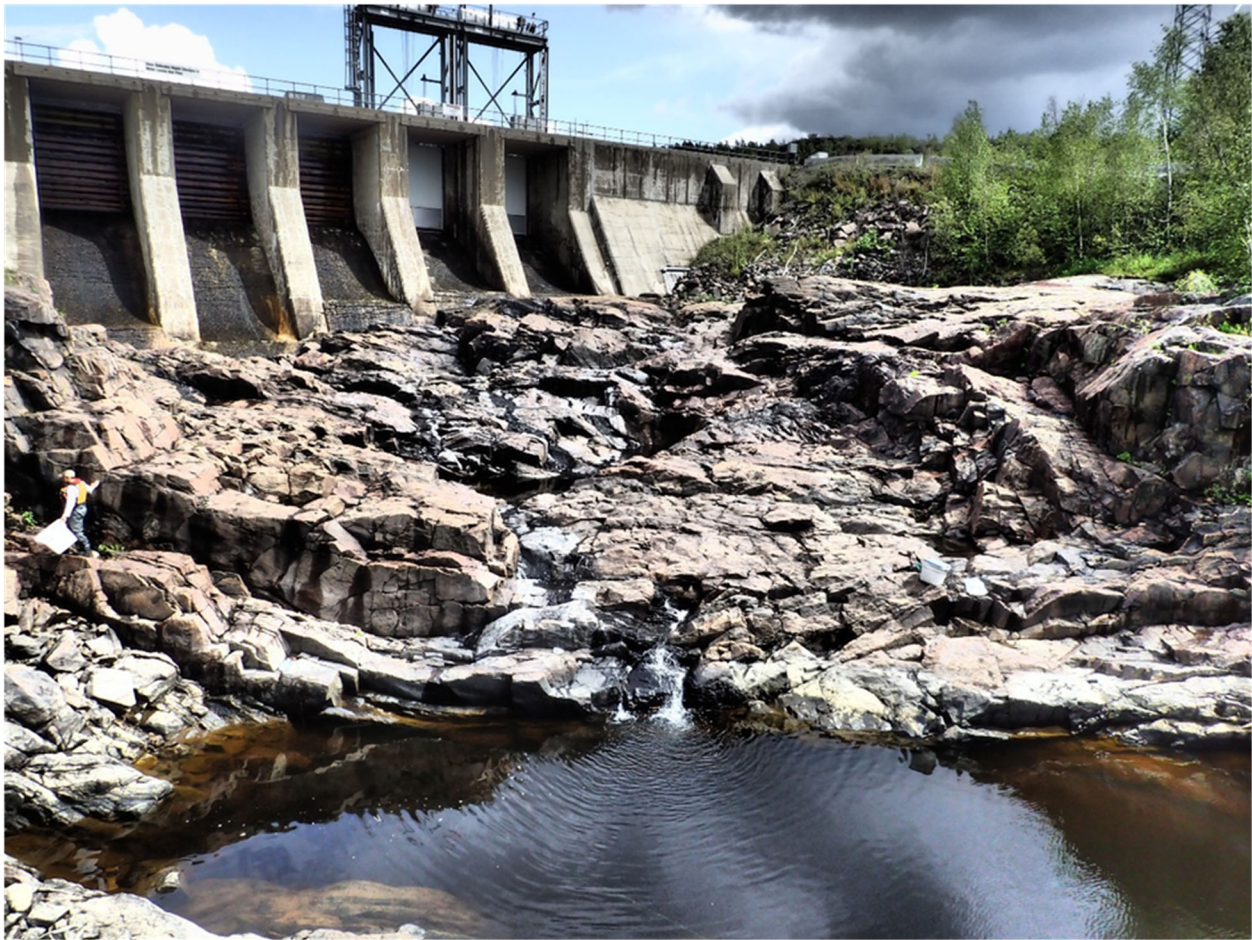
Upstream fish passage is not possible at the Coniston GS and downstream passage can only occur through the GS or via the spillway when river flow exceeds the plant capacity. Based on the height and shape of the bedrock outcrop at the base of the dam at Coniston (Figure 3-6 below), it is likely that a complete barrier to upstream fish movement was present prior to dam construction. Murray (1857) indicated that the falls and rapids there resulted in an elevation change of 18.3 m over 0.42 km. (60 feet over 0.26 mile).

*Figure 3-6 Bedrock Outcrop at the Base of the Coniston Dam. Person near left margin provides scale. August 5, 2020.*
