Ontario Power Generation

# **Proposed Stinson Generating Station Life Extension Project (Final Draft)**

**Aquatic Environment  
Technical Support Document**

January 2025

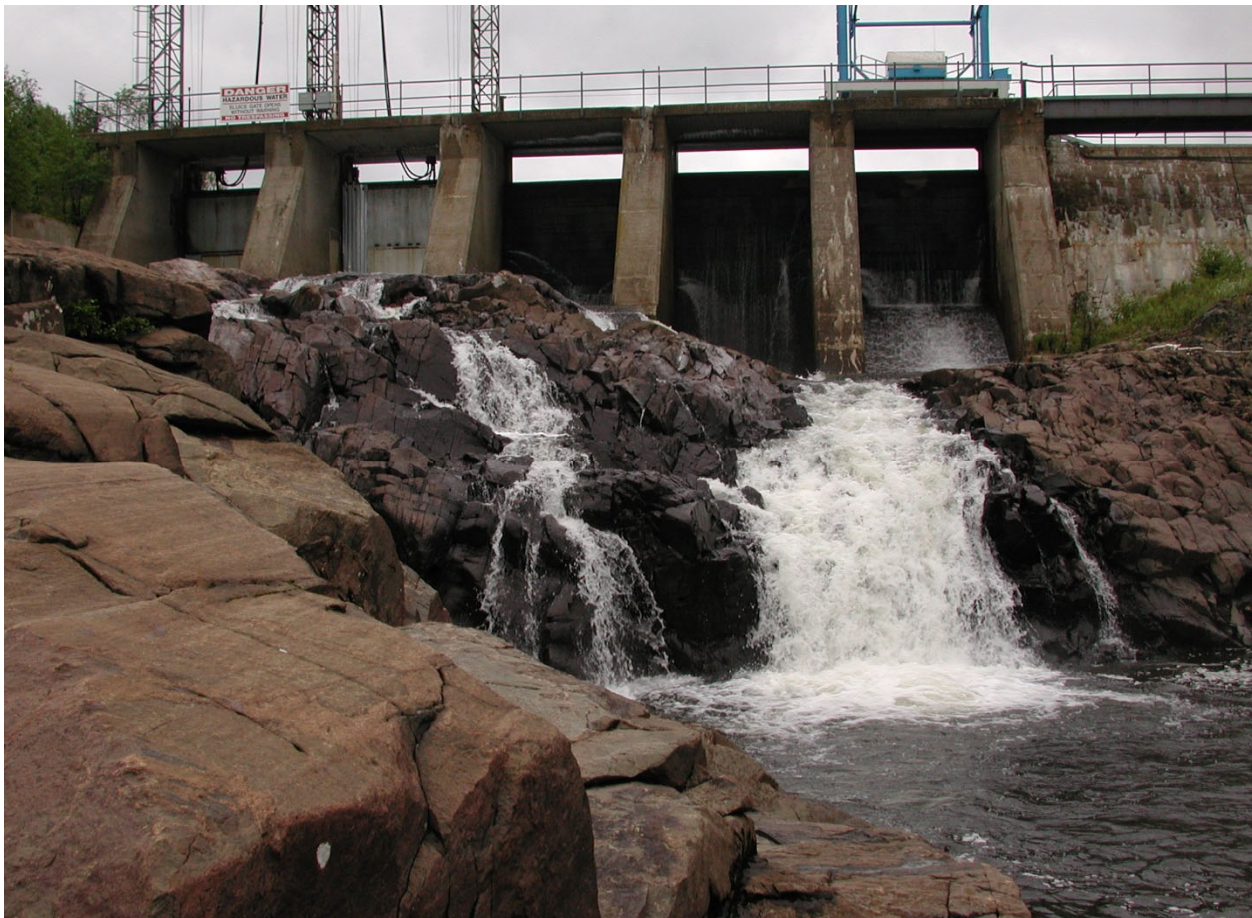
The McVittie GS, which is 27.5 km downstream from the Coniston GS, is also a complete barrier to upstream fish migration. It is likely that a complete barrier to upstream migration was also present at McVittie prior to the construction of the dam and generating station, based on the visible bedrock (Figure 3-7). There are three locations between the Coniston GS and the McVittie GS where, at a minimum, seasonal barriers to upstream migration are thought to occur. A steep bedrock chute is located approximately 17 km downstream of the Coniston GS, just upstream of Highway 400 at the south end of the village of Wanup, (Figure 3-8). Second Falls is approximately 20.1 km downstream from the Coniston GS (Figure 3-9) and aerial imagery shows a third bedrock outcrop located approximately 1.3 km upstream from the McVittie GS.

*Figure 3-7 Bedrock Outcrop at the Base of the McVittie GS Dam. August 22, 2002.*

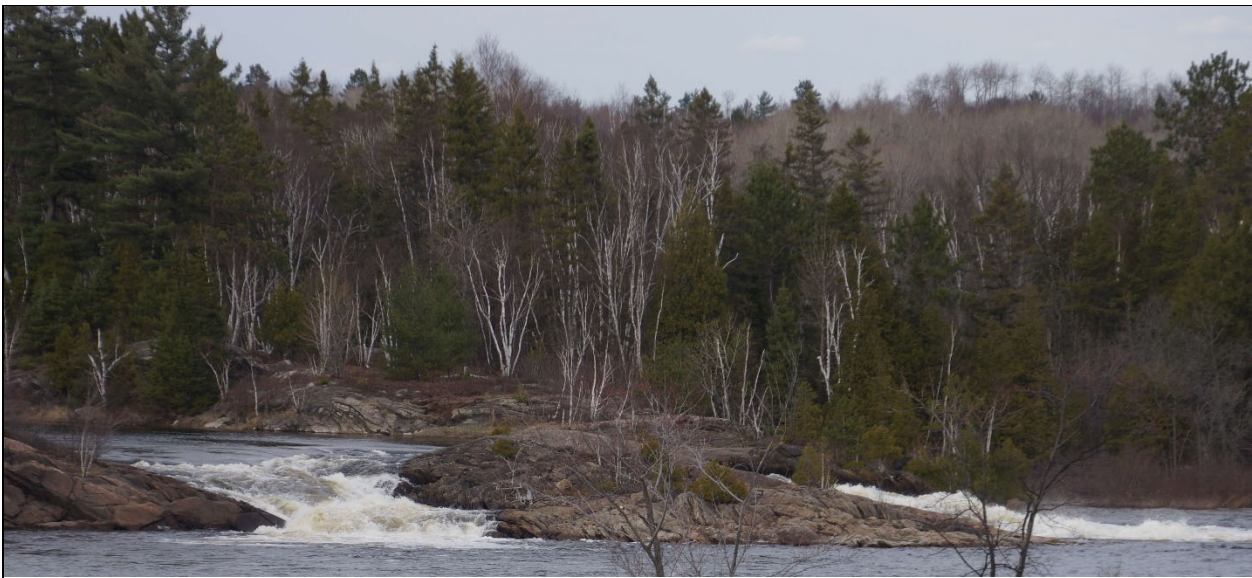
*Figure 3-8 Steep Bedrock Chute on the Wanapitei River, 17 km Downstream from the Coniston GS. May 3, 2016.*

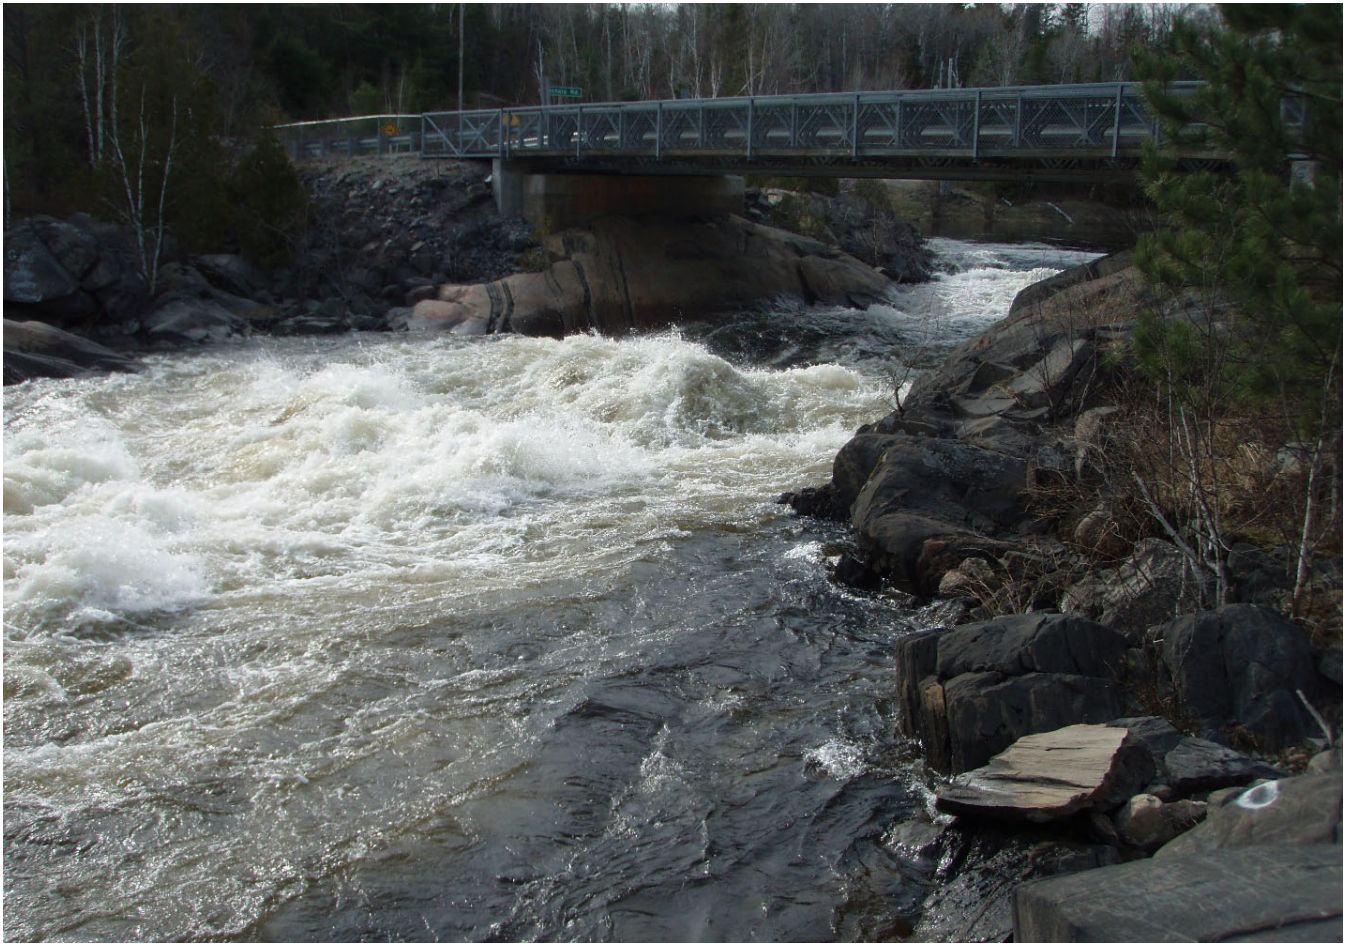
*Figure 3-9 Second Falls, Approximately 20.1 km Downstream from the Coniston G.S. May 3, 2016.*

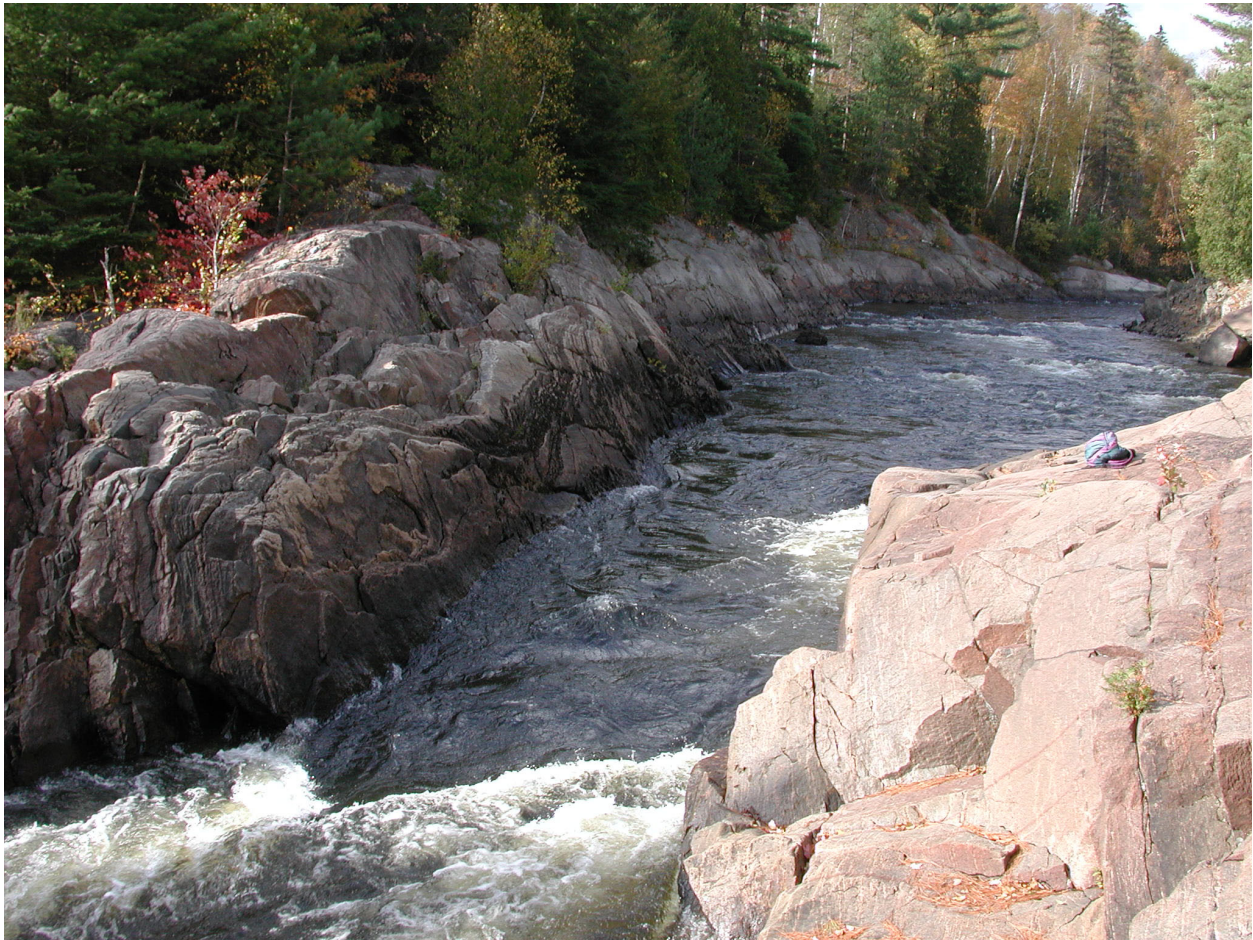
There are four more locations between the McVittie GS and the French River that are thought to be at least partial barriers to upstream fish migration. A bedrock chute approximately 4 meters wide, 3.25 km downstream from the McVittie GS (Figure 3-10) was examined during field investigations supporting the environmental assessment for the McVittie GS and considered to be a barrier to upstream migration by most fish species under most flow conditions. (C. Portt and Associates, 2004). The river crosses bedrock outcrops approximately 19 km downstream (just downstream from the Highway 637 bridge) and 26 km downstream from the McVittie GS, which may be barriers under some flow conditions. Sturgeon Chutes, located approximately 38 km downstream from the McVittie GS and 5 km upstream from the confluence of the Wanapitei and the French Rivers, may also be a barrier to upstream migration by some species under some flow conditions.

*Figure 3-10 Rock Chute Approximately 3.25 km Downstream from the McVittie Generating Station. October 15, 2002.*

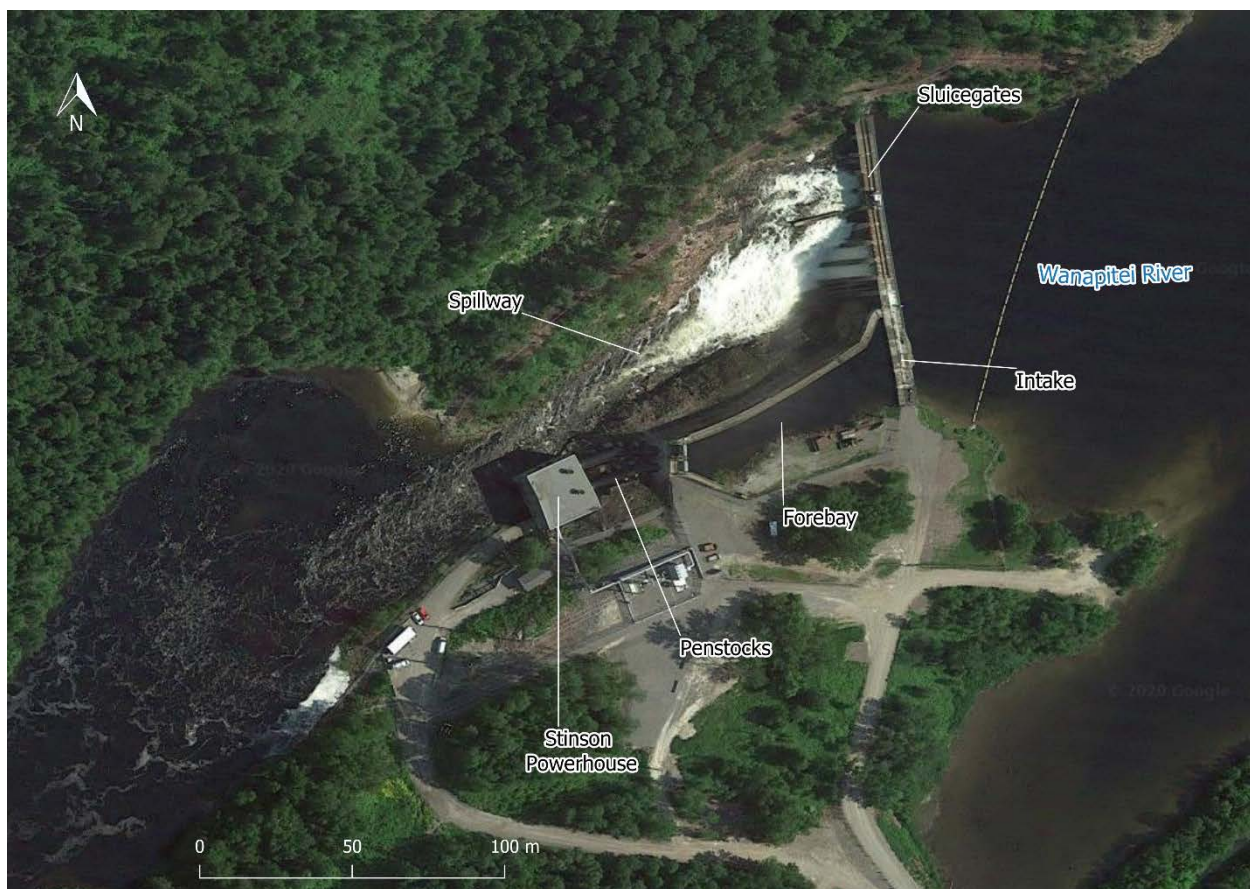
Figure 2-1. Wanapitei River in the vicinity of the Stinson GS.

Figure 2-1 illustrates the general habitat and flow conditions in the vicinity of the GS and identifies project infrastructure. The Stinson GS bypasses water around a 140 m section of river that is now the spillway. The forebay, located between the intake and penstocks is approximately 75 m long. Water discharged from the powerhouse enters the river directly, as there is no tailrace.

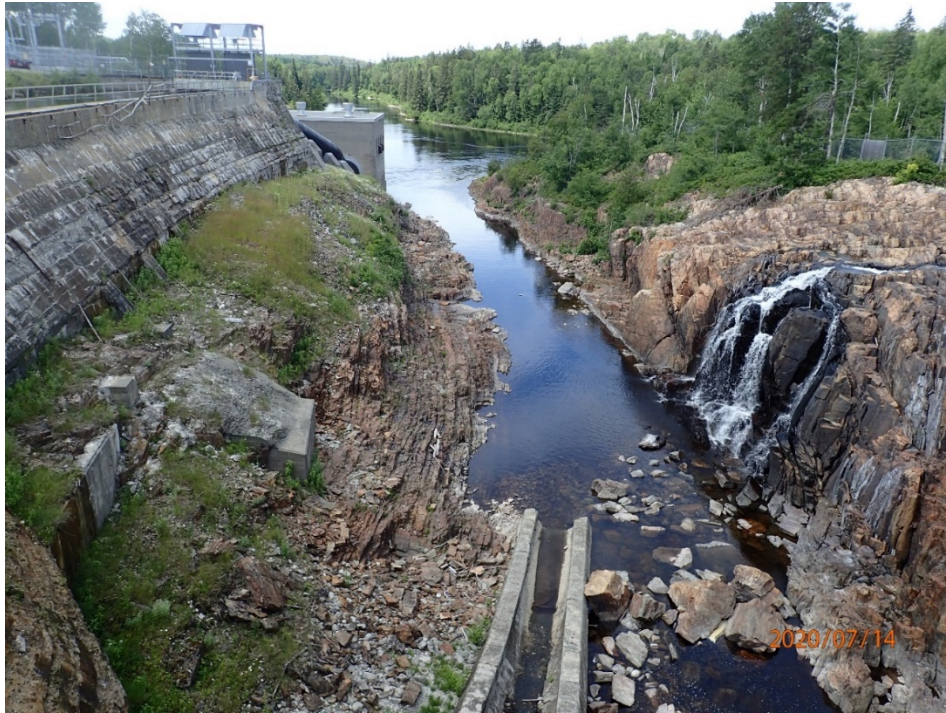
Figure 3-3. Looking downstream at the spillway at the Stinson GS on July 14, 2020 (see Figure 3-2 for approximate location). The bedrock in the upper spillway transitions to boulder and cobble substrate downstream.

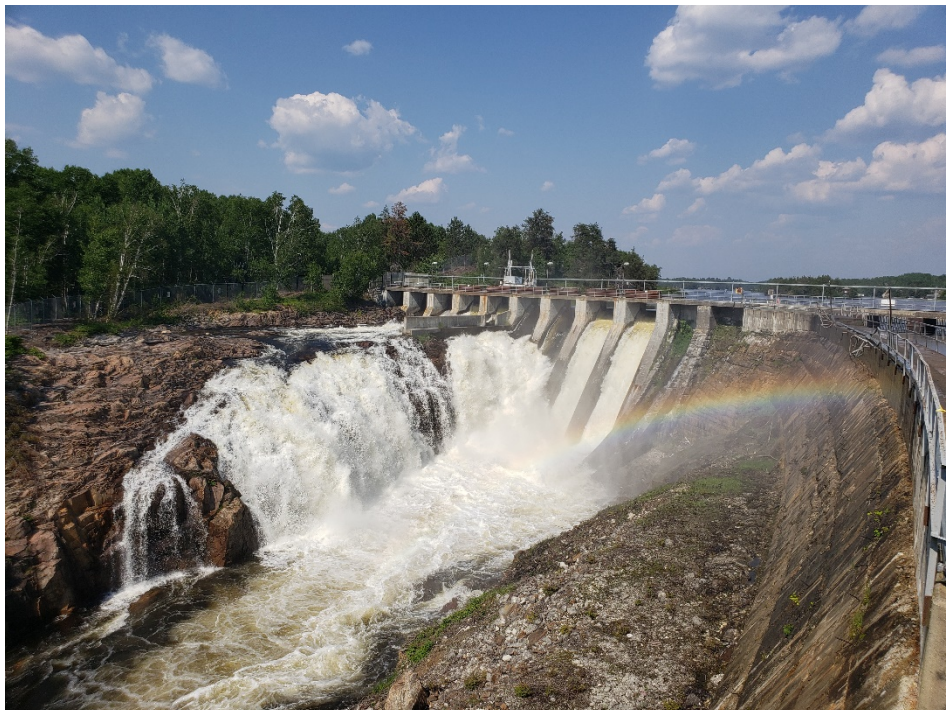
The results of the habitat mapping are presented in Figure 3-2. The spillway consists of a broad, steep bedrock outcrop in the upstream section, below the dam, which flows into a steep-sided channel, with poorly sorted boulder and cobble substrate (Figure 3-3 and Figure 3-4). Immediately downstream of the powerhouse the river widens, with cobble/boulder substrates dominating the higher velocity areas and sand and gravel substrate, with macrophytes present, in the low velocity, backwater areas (Figure 3-5). Farther downstream of the powerhouse, the river is deeper and lower velocity, with substrates dominated by cobble and gravel (Figure 3-6). Based on substrate, and expected spring water velocities, the most likely location for Walleye and White Sucker spawning to occur is the shallow cobble/gravel area that is approximately 90 m downstream from the GS.

Figure 3-4. Looking upstream at the spillway and sluiceways at the Stinson GS on July 2, 2019 under higher flow conditions than present during field investigations in 2020 (OPG supplied photo, see Figure 3-2 for approximate location).

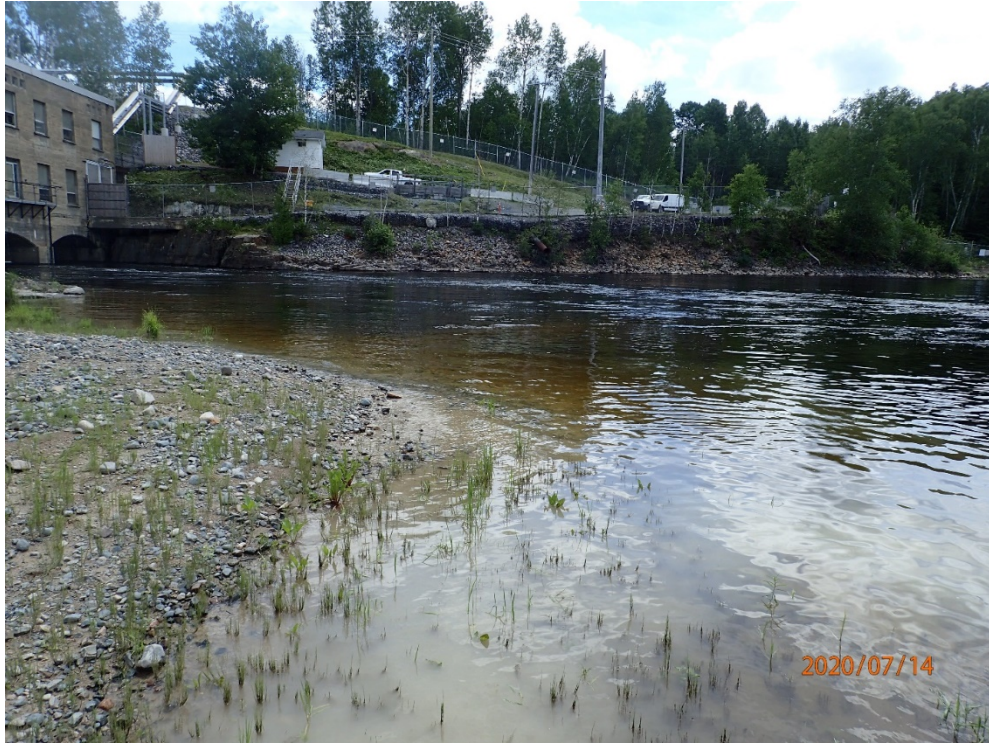
Figure 3-5. Looking across the Wanapitei River immediately downstream of the Stinson powerhouse on July 14, 2020 (see Figure 3-2 for approximate location). Sand, gravel, and macrophytes are present in the low velocity portion of the stream in foreground, while cobble/boulder substrate dominates the higher velocity areas nearer the powerhouse.

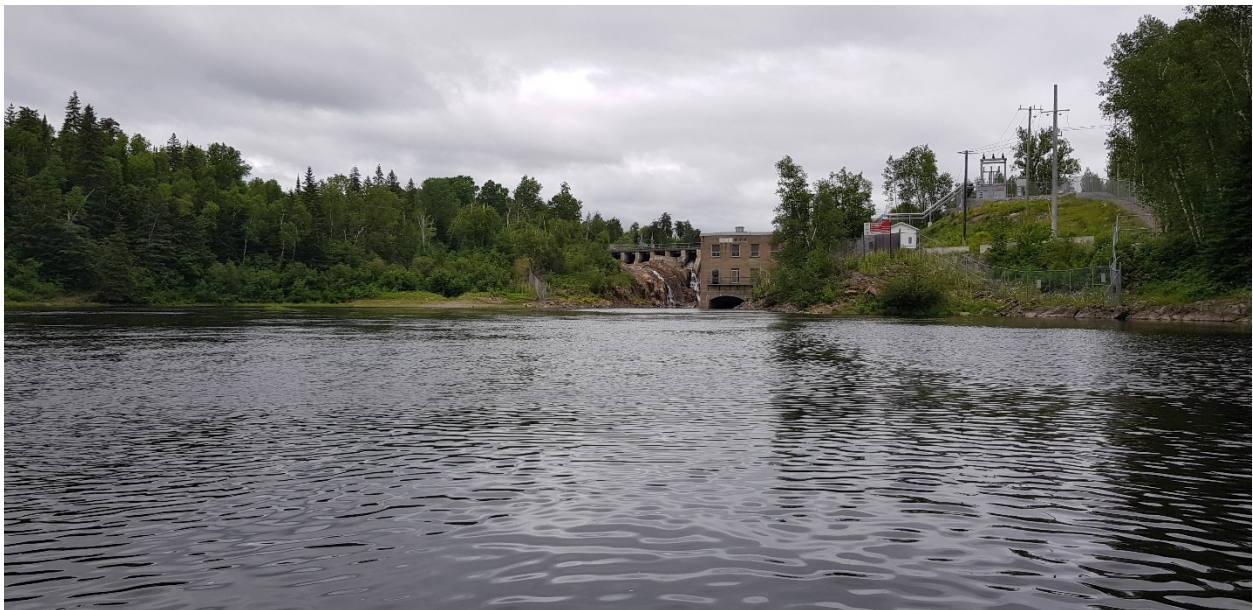
Figure 3-6. Looking upstream at the, wide, low velocity area downstream of the Stinson GS on July 13, 2020 (see Figure 3-2 for approximate location).

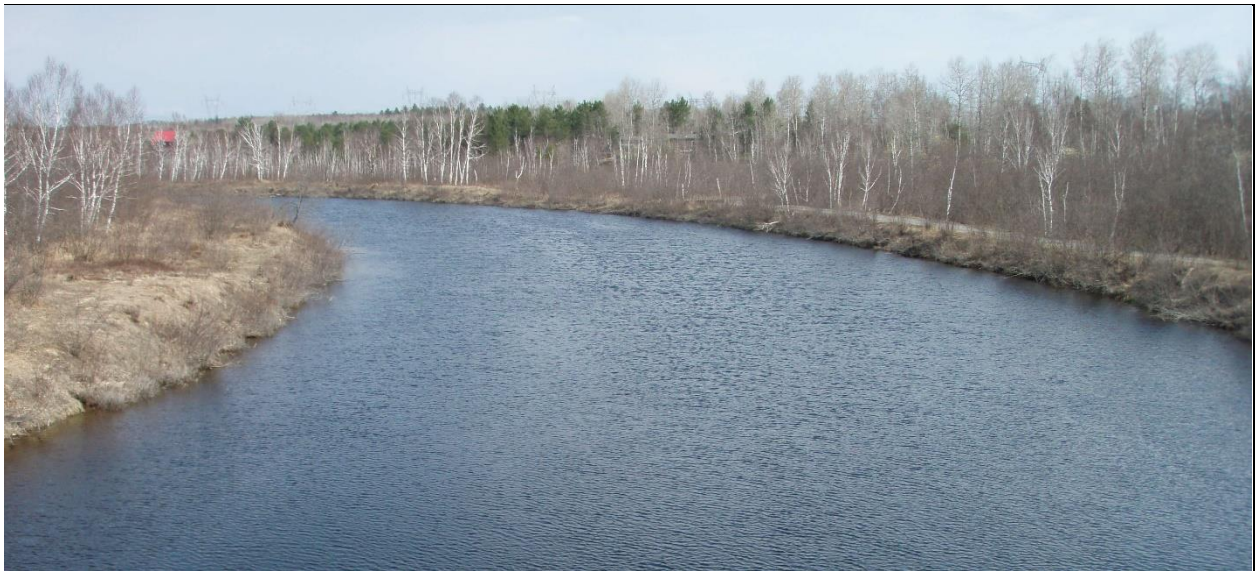
McVittie GS, Coniston GS, and Stinson GS are all barriers to upstream fish passage. Downstream passage at the Stinson GS can only occur through the GS or via the spillway when river flow exceeds the plant capacity. Based upon aerial photography, other than the generating stations there is only a small number of other short rapids or chutes that punctuate the river along the 38.7 km of channel between the Stinson GS and the McVittie GS. Between these few rapids, chutes and generating stations, there are long sections where the river is generally deep flatwater (Figure 2-1).

Figure 2-1. Typical flatwater section of the Wanapitei River. Upstream view from Hwy 537 bridge. May 4, 2016.

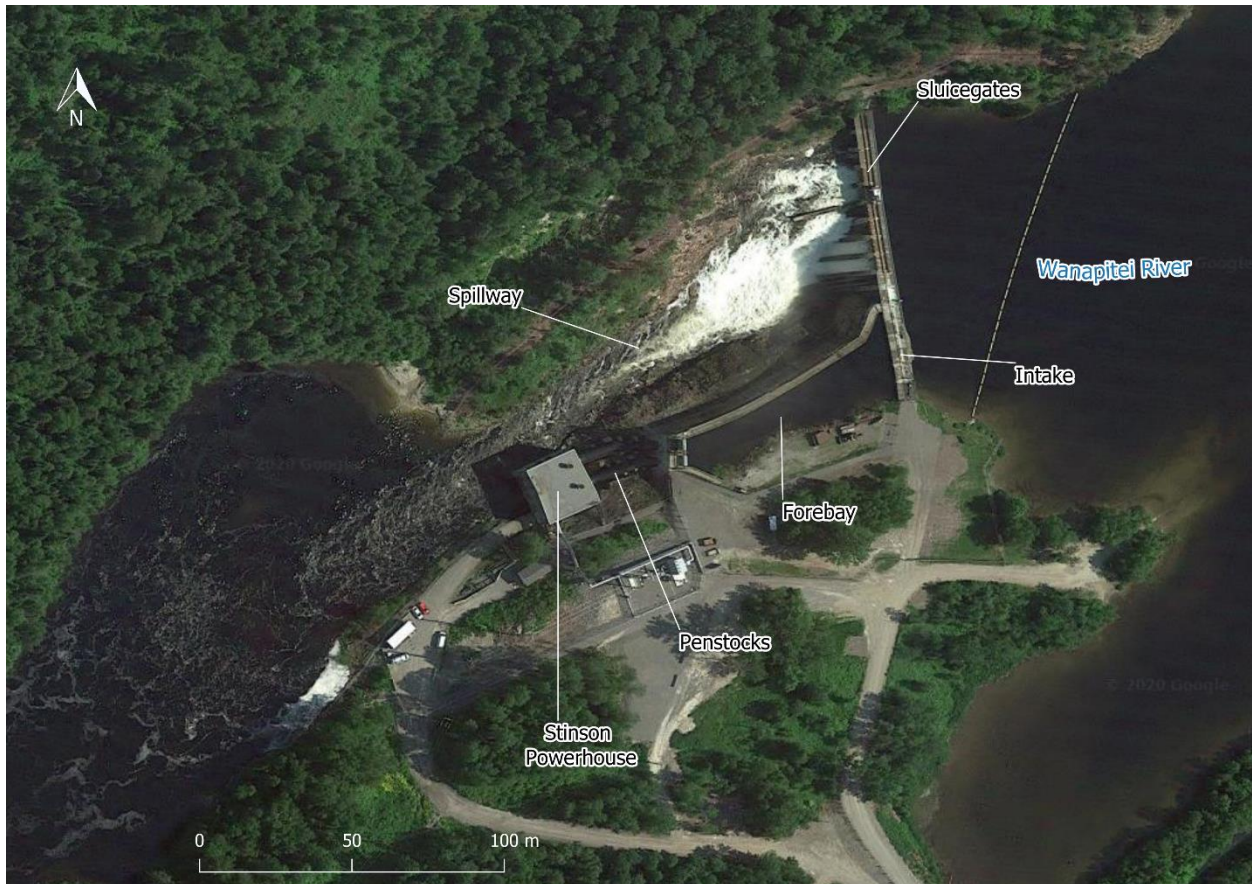
Figure 2-2 illustrates the general habitat and flow conditions in the vicinity of the GS and identifies project infrastructure. The Stinson GS bypasses water around a 140 m section of river that is now the spillway. The forebay, located between the intake and penstocks is approximately 75 m long. Water discharged from the powerhouse enters the river directly, as there is no tailrace.

Figure 2-2. Wanapitei River in the vicinity of the Stinson GS. Aerial photo taken on July 2, 2019. Major flow through dam and spillway.

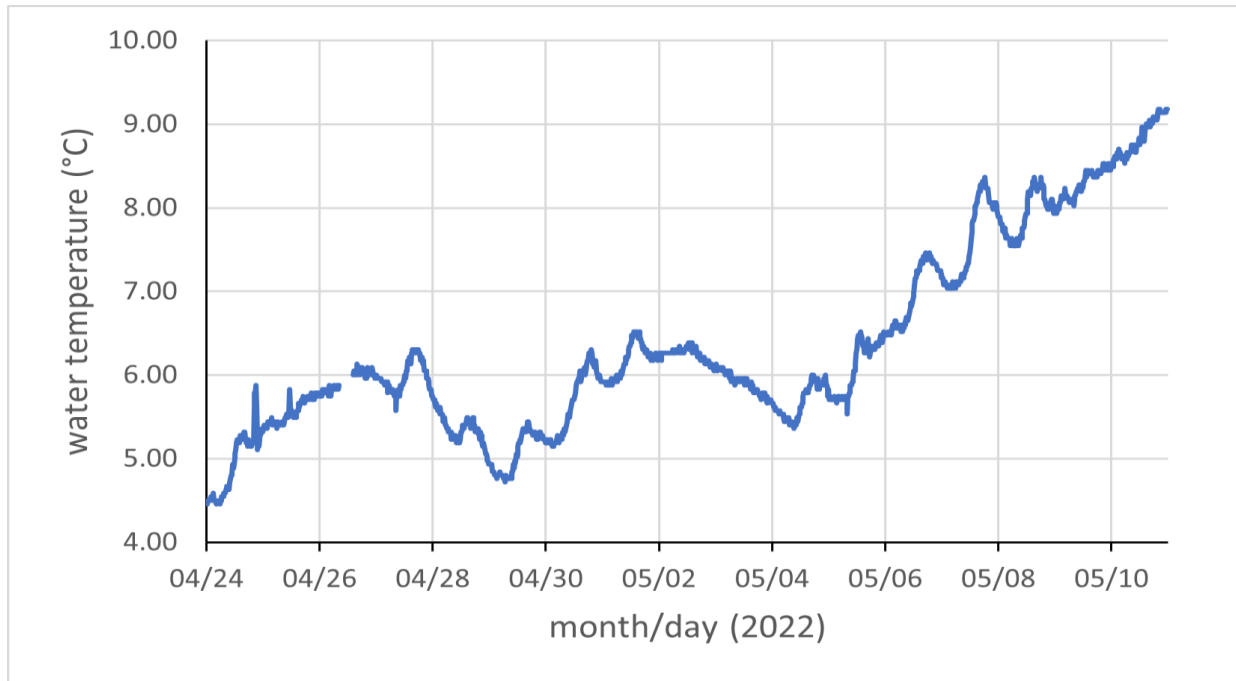
Flow through the GS was 46.7 m<sup>3</sup>/s on April 30 and May 1, 2022, with mean spillway flow being 23.8 m<sup>3</sup>/s and 23.5 m<sup>3</sup>/s, respectively. On May 9, 2022, flow through the GS was 44.9 m<sup>3</sup>/s, and flow in the spillway was 15.9 m<sup>3</sup>/s.

Figure 3-1. Logged water temperature in the Stinson GS tailrace for the period April 24 – May 11, 2022.

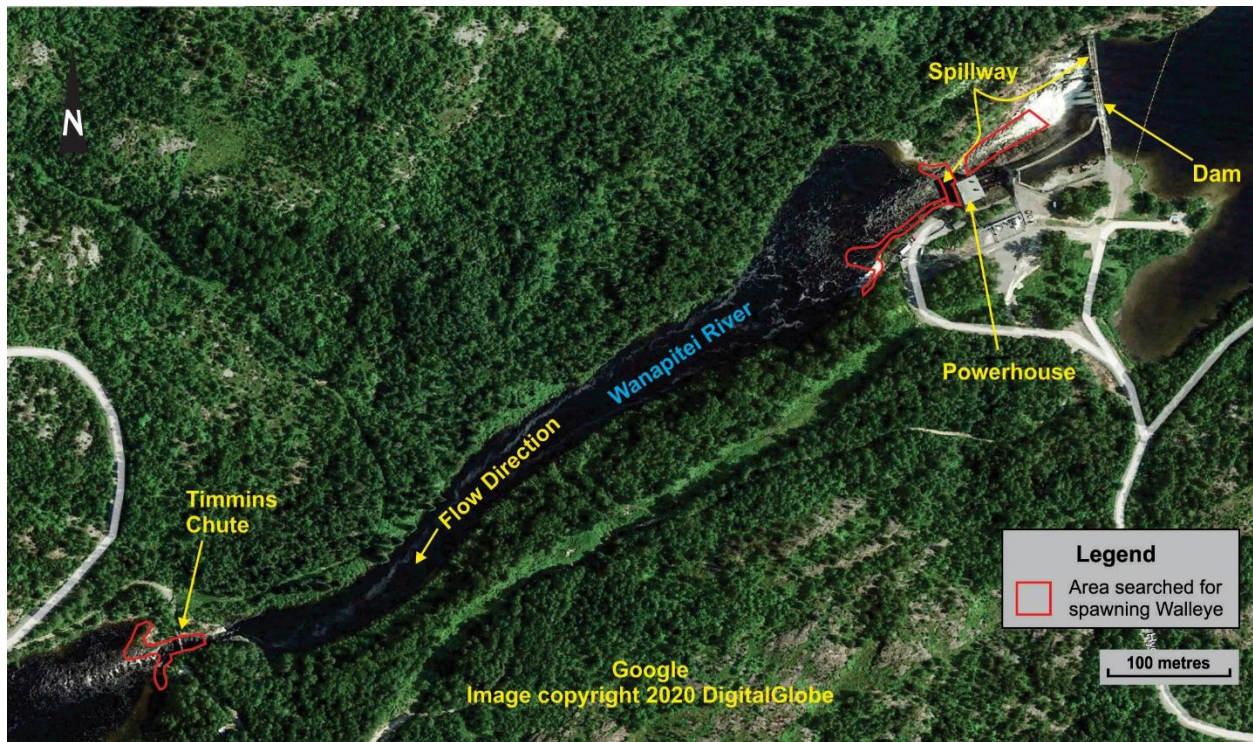
Figure 3-2. Area examined for Walleye on April 30, May 1, and May 9, 2022.

The areas examined during the spawning survey at the Stinson GS are shown in Figure 3-2. No Walleye were observed in the immediate vicinity of the Stinson GS on any of the three nights, however, a small number were observed each night immediately downstream of Timmins Chute, which is 750 m downstream of the Coniston GS. Two Walleye were observed on April 30; three on May 1; and four on May 9, 2022. They were observed in very close proximity to each other, indicating that spawning was ongoing. It is suspected that the length of the Timmins Chute, and the water velocity that was estimated at 3-4 m/s in the centre of flow (Figure 3-3), prevented Walleye from moving upstream to the Stinson GS under the prevailing river flow conditions. Also, the 11.23 km section of the Wanapitei River, downstream of the Stinson GS to the Coniston GS, likely does not support a large Walleye population that might spawn in the vicinity of the Stinson GS.

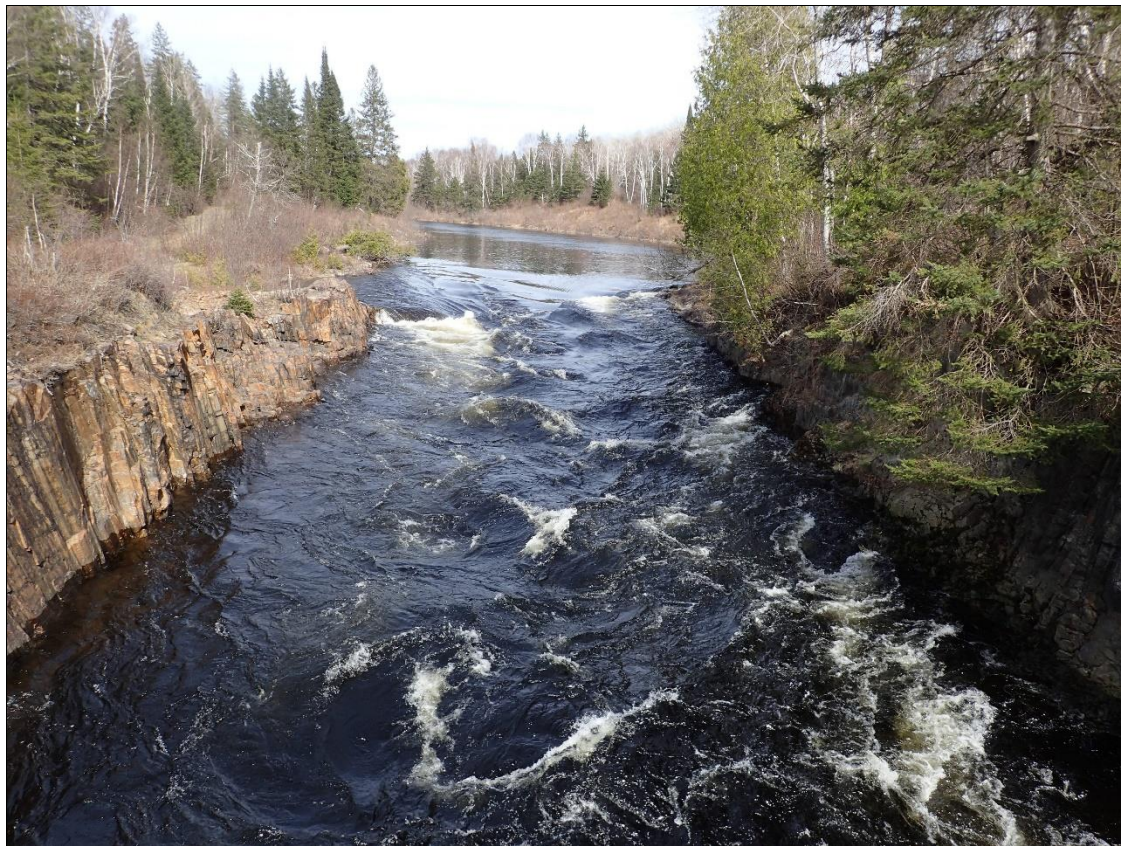
Figure 3-3. Upstream portion of Timmins Chute, viewed from the snowmobile/pedestrian bridge. May 9, 2022.

*Figure 3-5 Upstream Portion of Timmins Chute, Viewed from the Snowmobile/Pedestrian Bridge. May 9, 2022.*

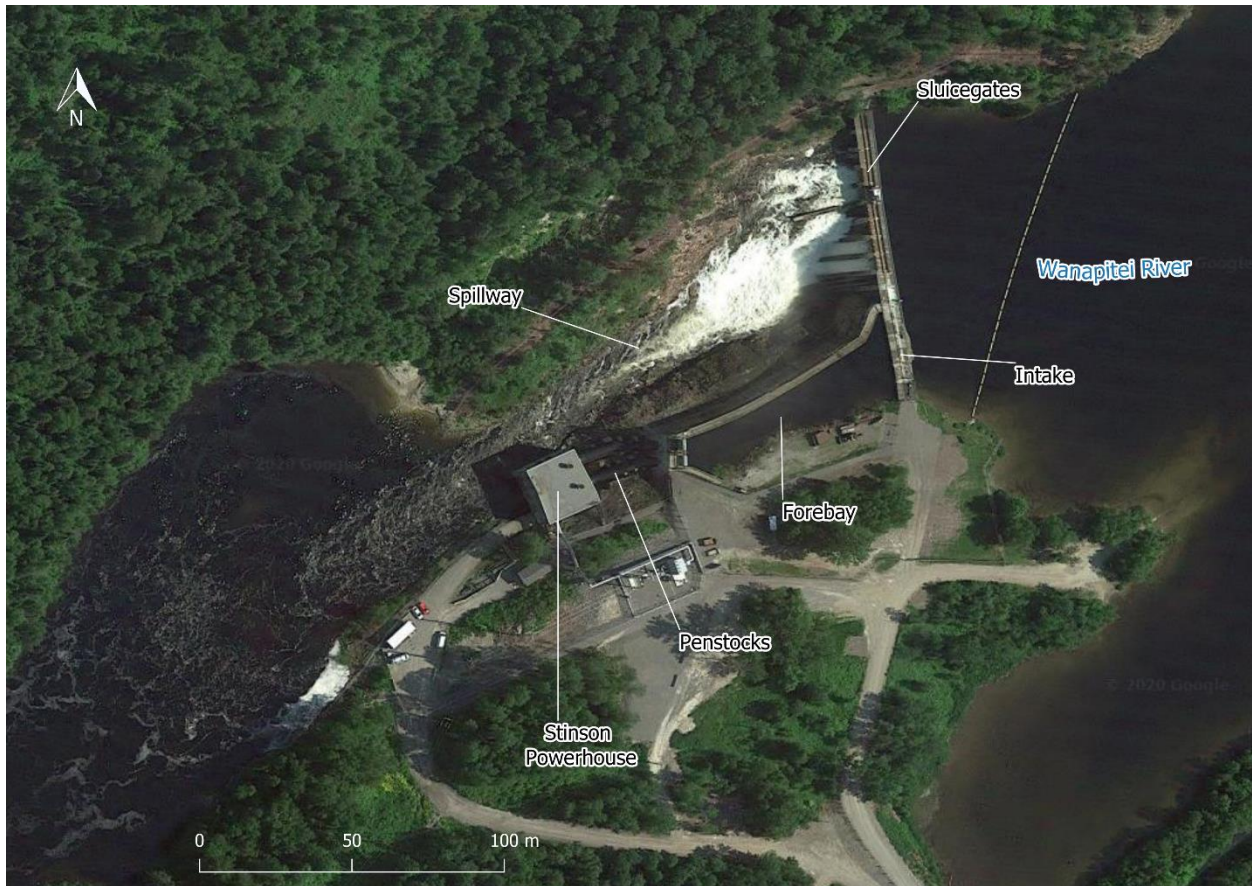
Figure 2-2 illustrates the general habitat and flow conditions in the vicinity of the GS and identifies project infrastructure. The Stinson GS bypasses water around a 140 m section of river that is now the spillway. The intake channel, located between the intake and penstocks is approximately 75 m long. Water discharged from the powerhouse enters the river directly, as there is no tailrace.

Figure 2-2. Wanapitei River in the vicinity of the Stinson GS. Aerial photo taken on July 2, 2019. Major flow through dam and spillway.

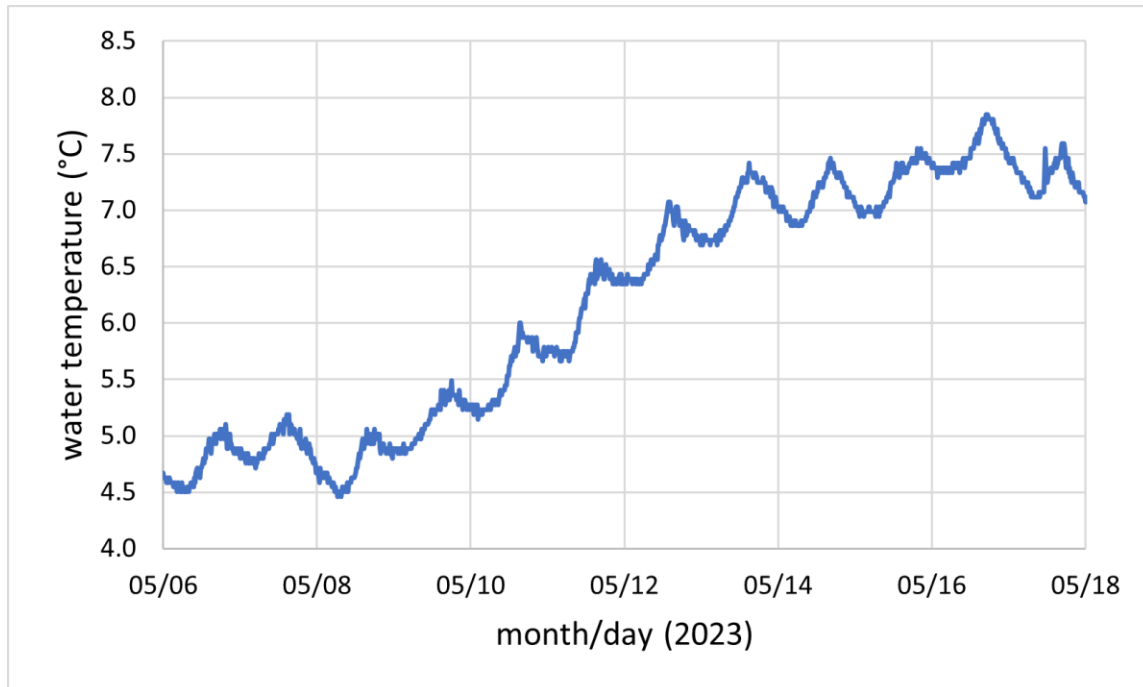
Figure 3-1. Logged water temperature in the Stinson GS tailrace for the period May 6 – May 17, 2023.

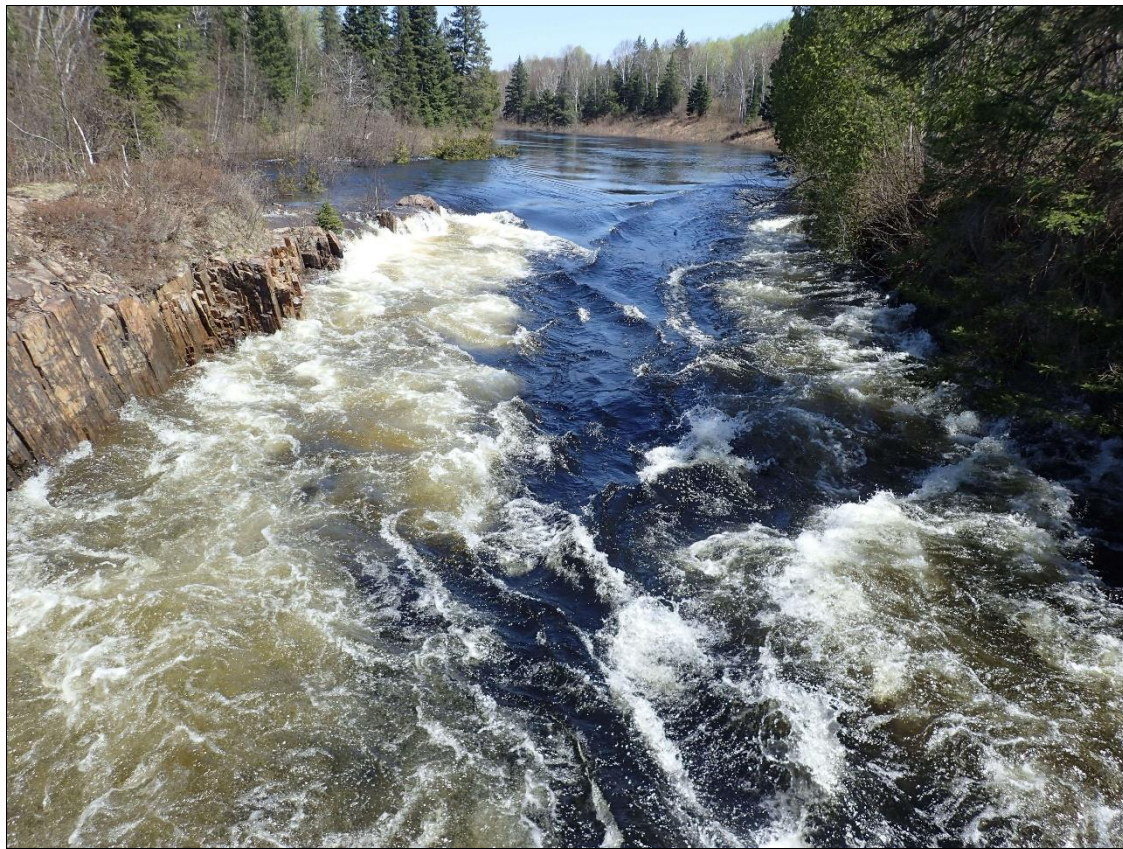
Figure 3-3. Upstream portion of Timmins Chute, viewed from the snowmobile/pedestrian bridge. May 13, 2023.
